# **Slamannan Bog**

## **Restoration Project**

### *Year 1 Report*

23rd November 2015

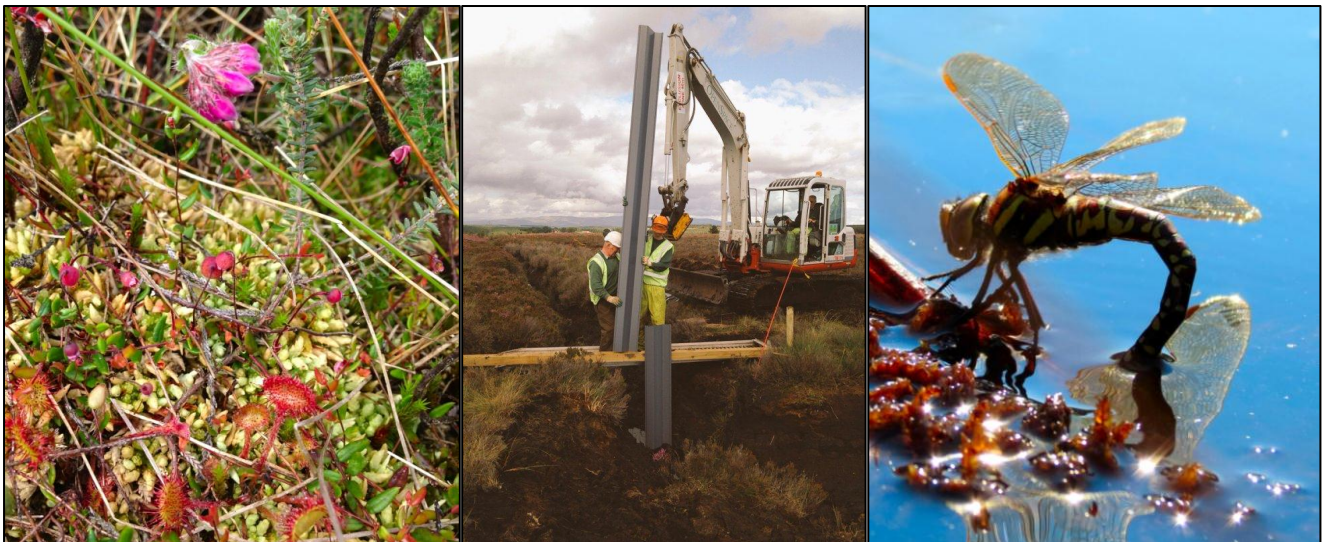
**Left: Bog vegetation in monitoring quadrat. Centre: Installing piling dams. Right: Common hawker dragonfly egg-laying in bog pool**

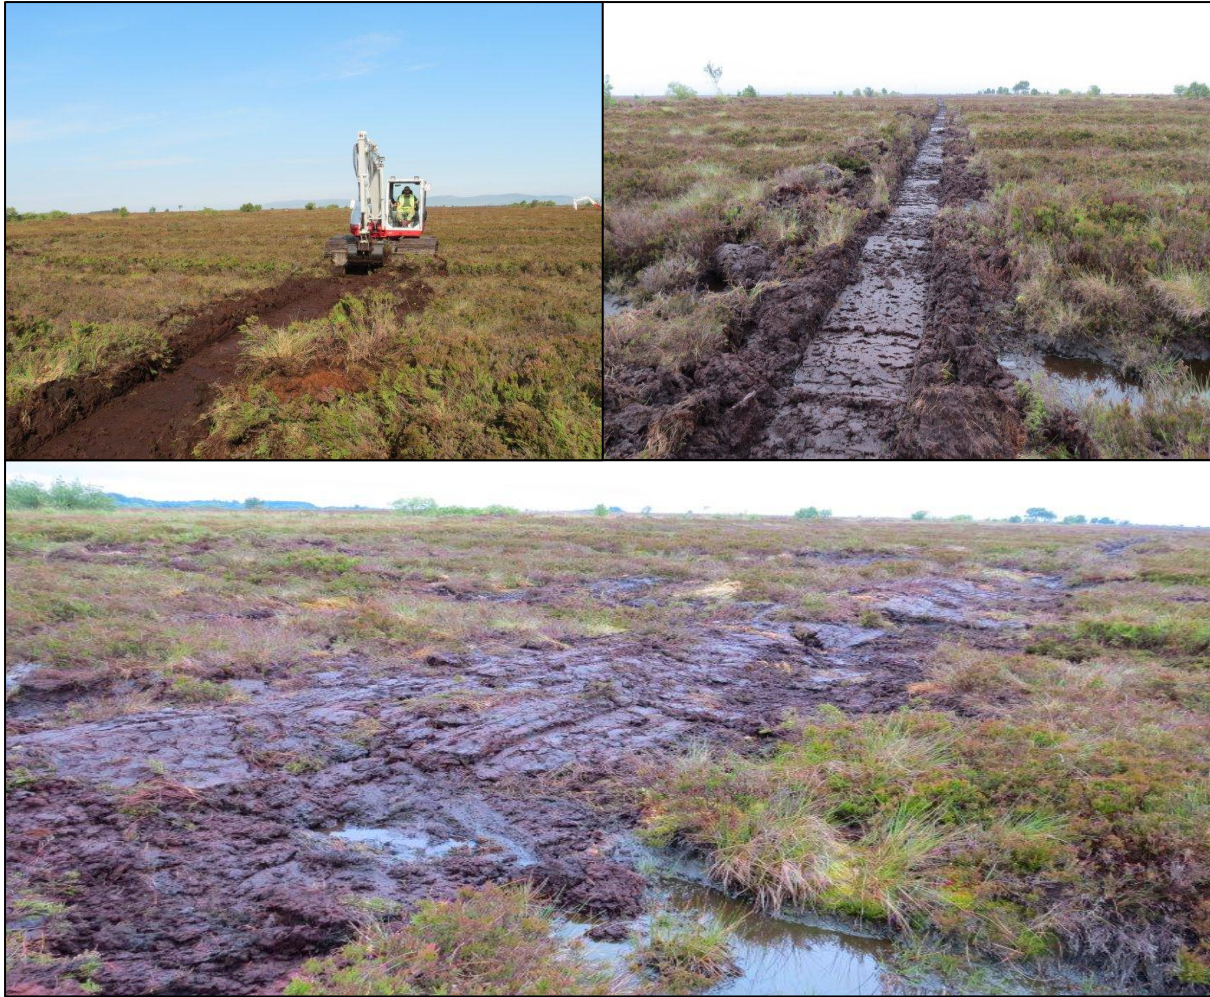
**Figure 1. Installation of trench bund in Compartment 13a.**

Top Left: Excavator installing trench bund (2 m deep). Top Right: Compressed surface of peat bund prior to capping with a dome of peat and vegetation. Bottom: 0.5m high cap of peat and vegetation along top of trench bund.

When it became clear that cross-tracking would have only limited effectiveness in compartments 8 and 13a, other techniques were considered. A 670m long trench bund (approximately 2m deep and 1.5m wide with a 0.5m high 'bund ridge' on the surface) was installed to block the main ditches and the narrow slit drains in the ridges of compartment 13a. The trench bunding technique involves digging down approximately 2m with an excavator bucket, churning the peat and then compressing it with the bucket to create an underground 'wall' of dense peat. A cap of peat and bog vegetation is then placed on top of the trench bund to hold surface water, but the main goal is to block the sub-surface slit drains and hidden cracks in the dried peat ridges, and thereby retain more water in the bog. A series of peat dams along secondary ditches in compartment 8 were also installed to slow the movement of water and encourage sphagnum growth. (See Figure 1).

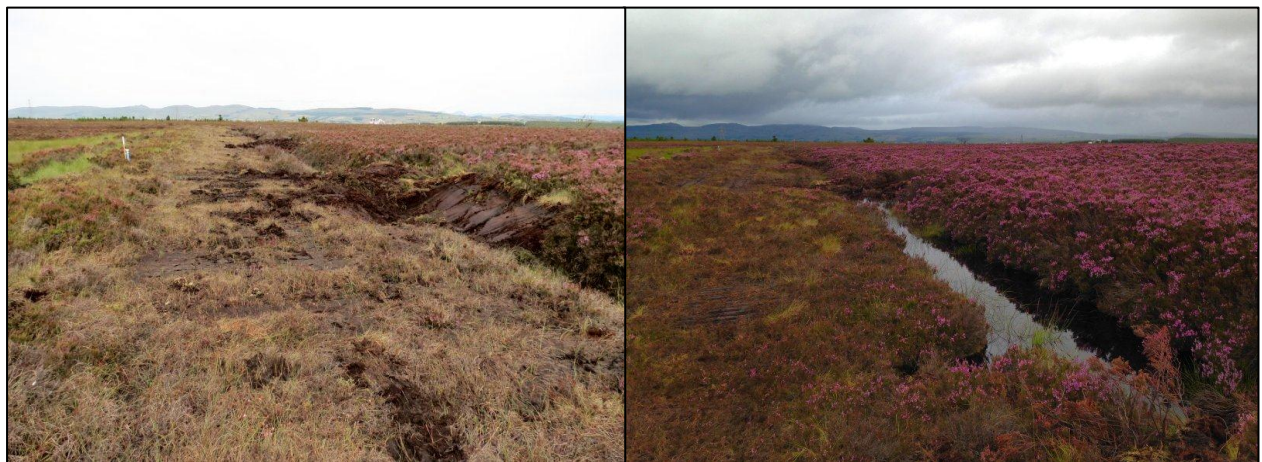
**Figure 2. Peat dams on ditch between Compartments 7 and 8.**

Left: Just after installation. Right: Late September- blocked ditches filling with water.

A total of 910 peat dams were installed on primary drains and a number of secondary drains during August and September 2015. Each peat dam is associated with a borrow-pit pool of approximately 4m<sup>2</sup> in size. This resulted in a significant increase in standing bog pool habitat, and almost immediately Common hawker (*Aeshna juncea*) and Black darter (*Sympetrum danae*) dragonflies were observed utilising this new resource to lay their eggs (despite the lack of aquatic vegetation). This is a greater number of peat dams than was initially planned for this year, and arose following discussions with the contractor when it became evident that cross-tracking would not be effective in restoring compartments 8 and 13a. Plastic piling dams were installed at the ends of runs of peat dams, and these were generally also backed with a peat dam for added strength. The extent of peat dam installation in subsequent years will be informed by how the site responds hydrologically to the initial phase of damming. (See Figure 2).

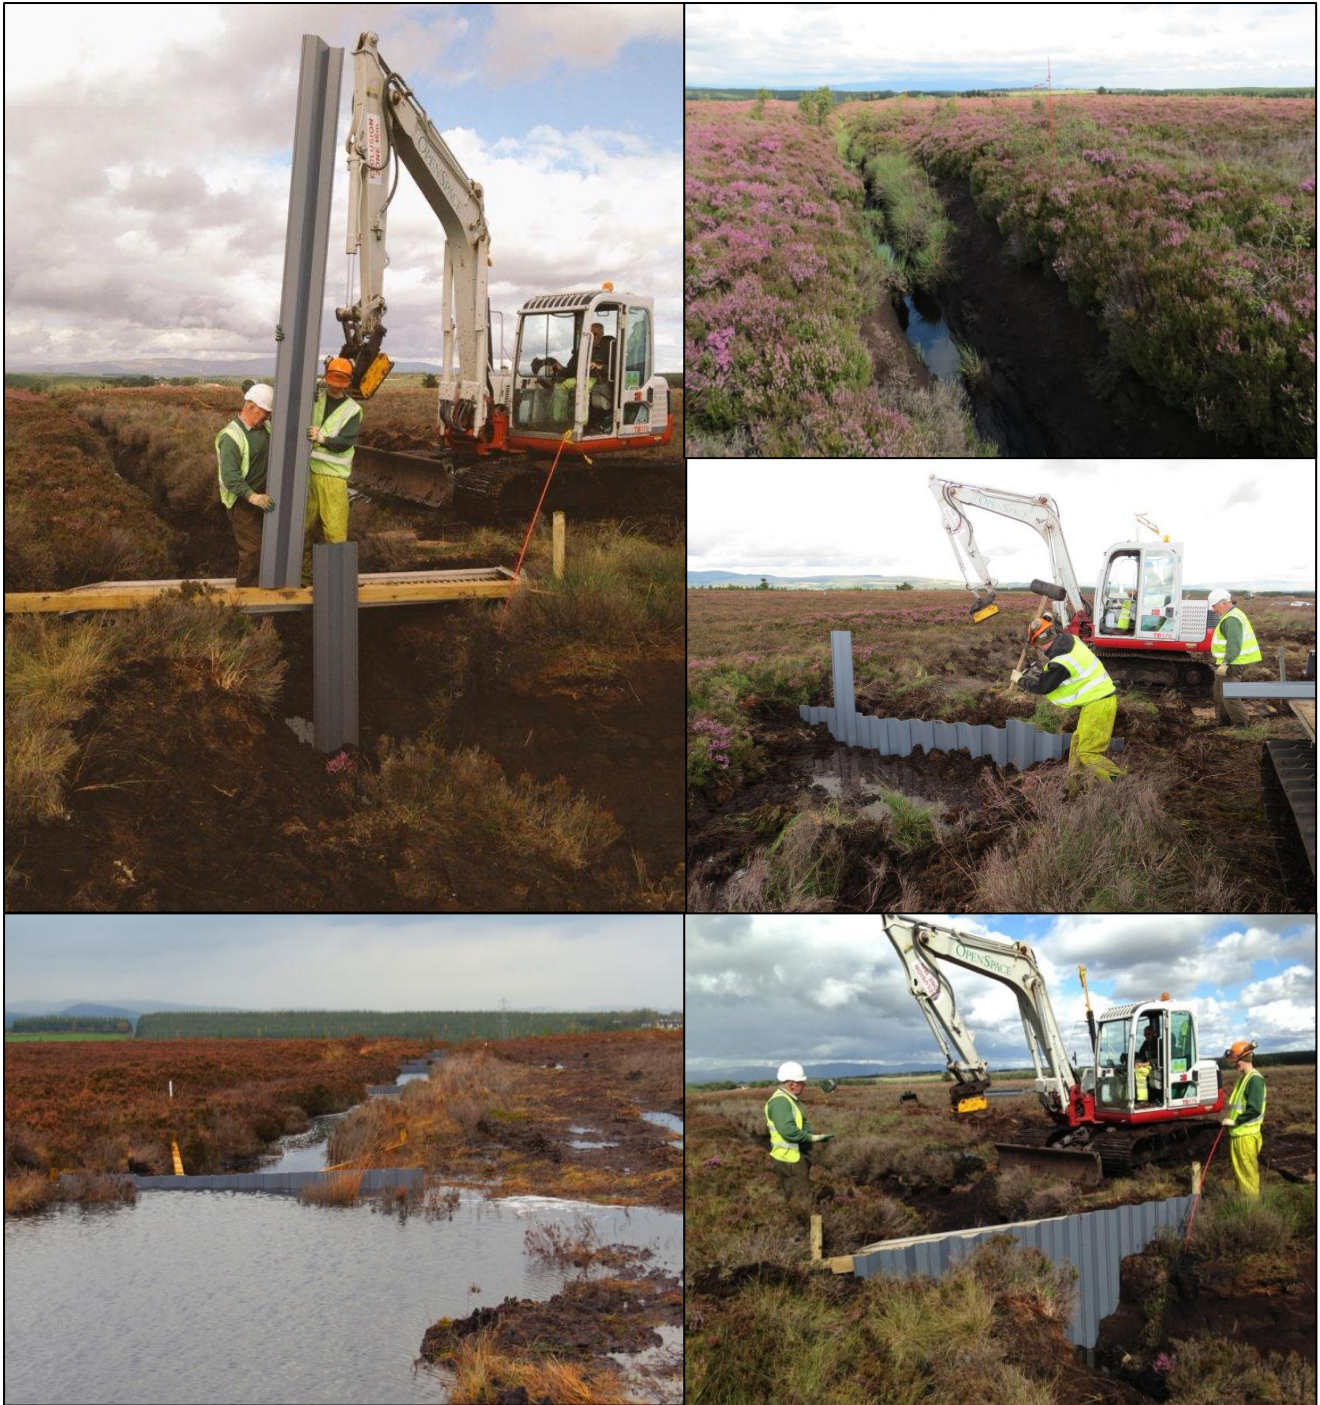
**Figure 3. Installation of 4m deep plastic piling dams on large ditch between Compartments 5 and 6 at Fannyside Muir.**

Clockwise from Top Left: First 4m piling dams being installed on deep boundary ditch.; Large eroded ditch prior to installation of piling dams.; Manual adjustment needed during installation of piling dams.(this one with peat back-filled for extra support); Supported piling dam before bracing timbers installed.; Same ditch very full of water in late October 2015.

Approximately 2,220 m of plastic piling was utilised in 90 dams installed across the restoration site in 2015. The use of plastic piling was kept to a minimum, but was required at the ends of long runs of peat dams and on wide or steeply inclined ditches where peat dams would likely wash out. Plastic piles of between 1.5 m and 4 m were used depending on the depth of ditches, with the majority being of 3m length. The majority of the piling dams were reinforced by timber bracing and supports where the ditch is wide or on an incline. The extent of plastic piling dam installation in the second year, and subsequent years will be informed by how the site responds to the initial phase of damming. Volunteer work parties in autumn/winter 2015 have helped to extend the width of a number of plastic piling dams to improve their water-holding potential. (See Figures 3 and 4).

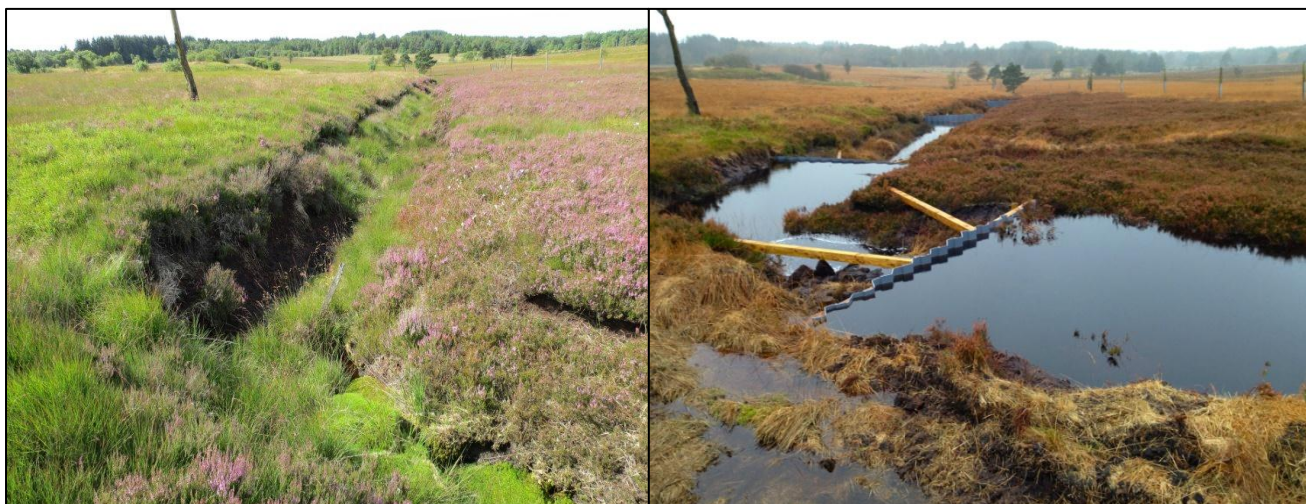
**Figure 4. Large ditch in Compartment 2 at Fannyside Muir before and after installation of reinforced plastic piling dams.**

Left: Before work began. Right: Same ditch in late October 2015 after 3 days of rain.

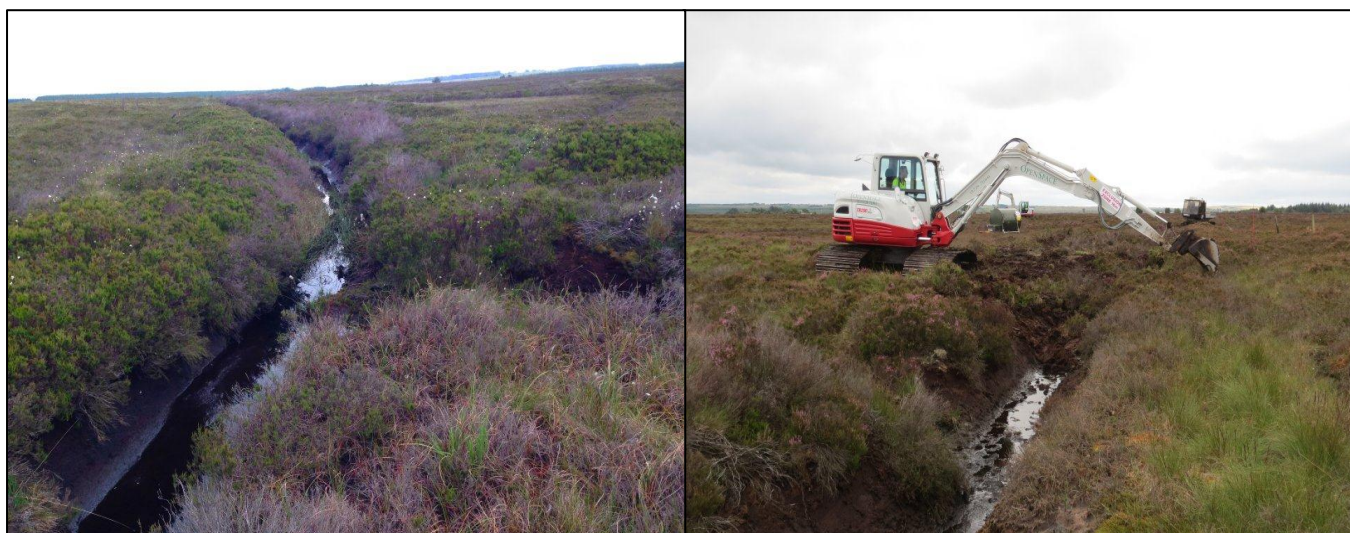
**Figure 5. Reprofiling steep-sided boundary ditch.**

Left: Before work began (Facing north-east). Right: Reprofiling and peat dam installation along ditch with excavator (Facing south).

A low ground pressure excavator was used to reprofile a 470m section of the steep-sided 2-3 m deep ditch that runs along the northwest boundary of compartments 7, 8 and 13a. During this procedure a 2m strip of surface vegetation on either side of the original ditch was removed and placed aside, then the ditch walls were reprofiled by partially collapsing the sides of the ditch to make them wider and shallower, additional excavator buckets of peat were 'borrowed' from further up the ditch to raise the ditch level further, then the strips of surface vegetation were restored to reduce erosion and promote drain occlusion. Peat dams were also installed at intervals along the length of the now shallower ditch. (See Figure 5).

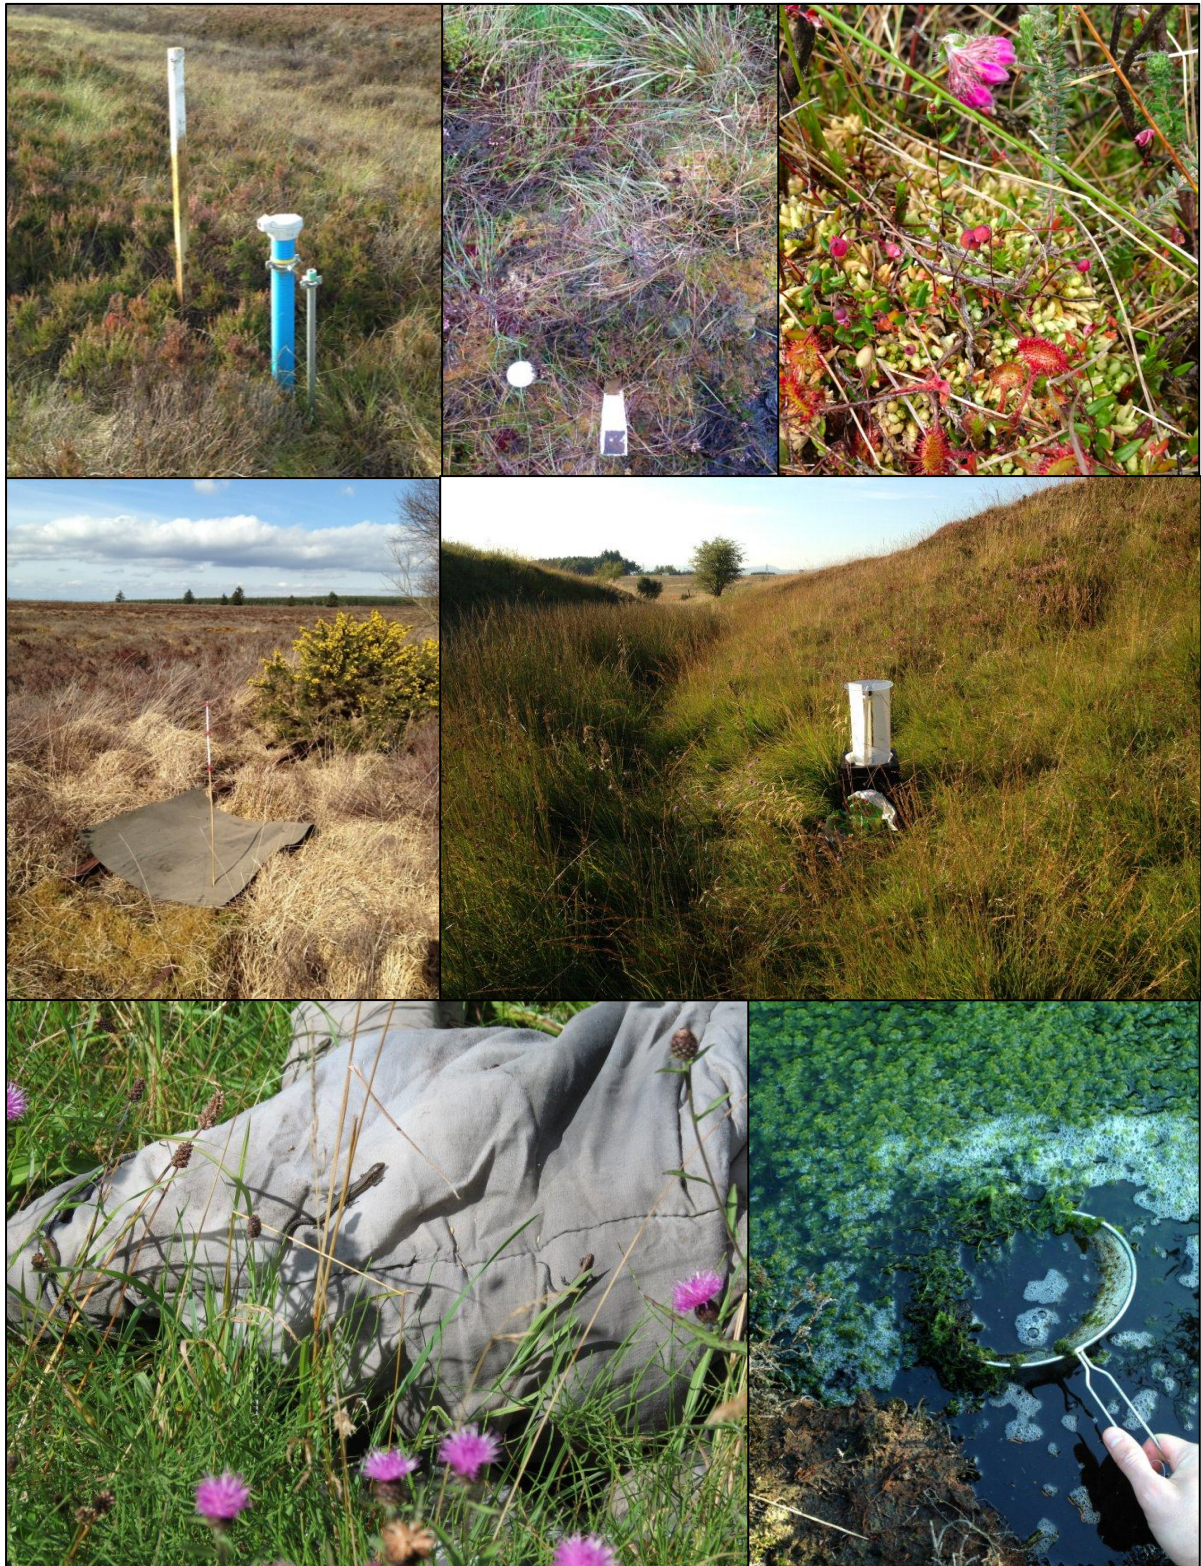
**Figure 8. Monitoring at Fannyside.**

Top Left: Water logger. Top Middle: Dipwell and mini-vegetation quadrat. Top Right: Species from control vegetation quadrat (*Sphagnum* sp., Cranberry, Cross-leaved heath, Round-leaved sundews). Centre Right: Reptile monitoring tile. Centre Left: Light trap (in gully between Compartments 1 and 2). Bottom Left: Five Common lizards (on abandoned duvet) in car park/ entrance area. Bottom Right: Sampling bog pool for aquatic invertebrates.
