Slamannan Bog Restoration Project- Summary of the second year

The Slamannan Bog Restoration Project began in September 2014 with the aim of restoring at least 150 hectares (ha) of degraded raised bog habitat in the Slamannan Plateau. The project is focused on an area of peatland called Fannyside Muir, 3km from Cumbernauld.

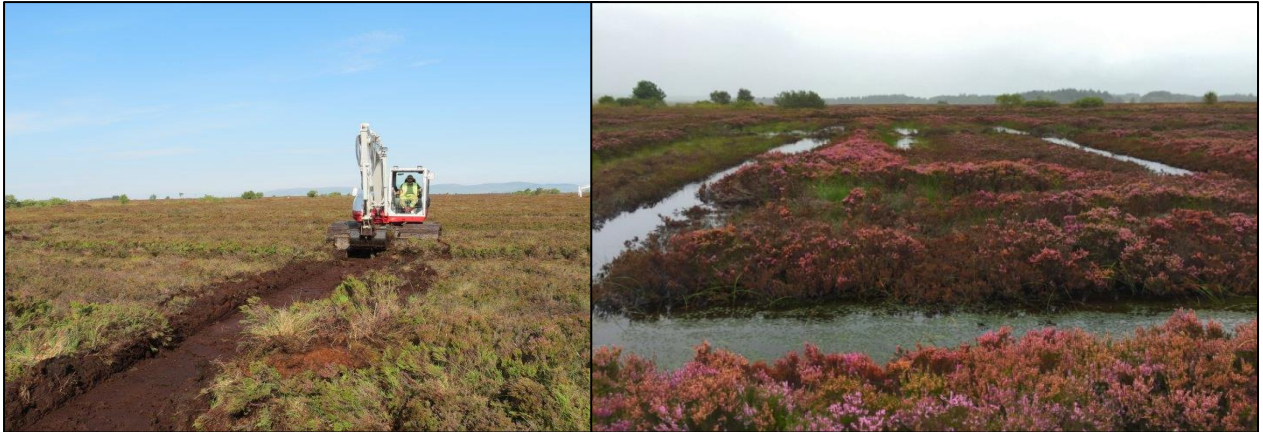
Figure 1. Installation of linear trench bund in Compartment 13a.

Top Left: Excavator installing trench bund (2 m deep) in August 2015. Top Right: Bund and peat dams working to raise water level to surface of compartment in August 2016.

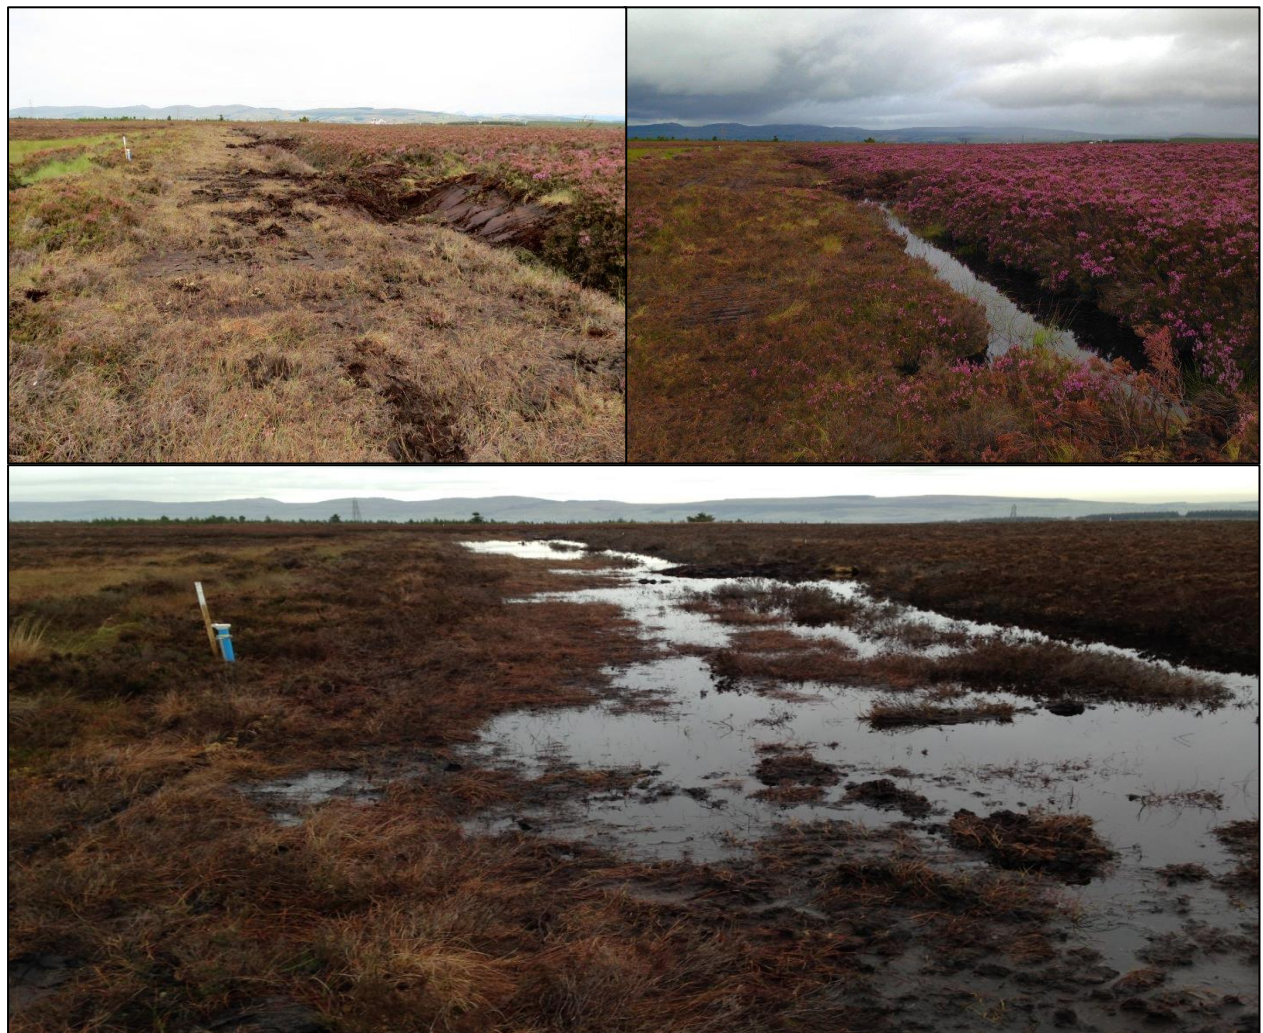
Figure 2. Peat dams on ditch between Compartments 7 and 8.

Top Left: Just after dam installation. Top Right: Late September 2015- blocked ditches filling with water. Bottom: March 2016- ground water raised to surface level of the peat.

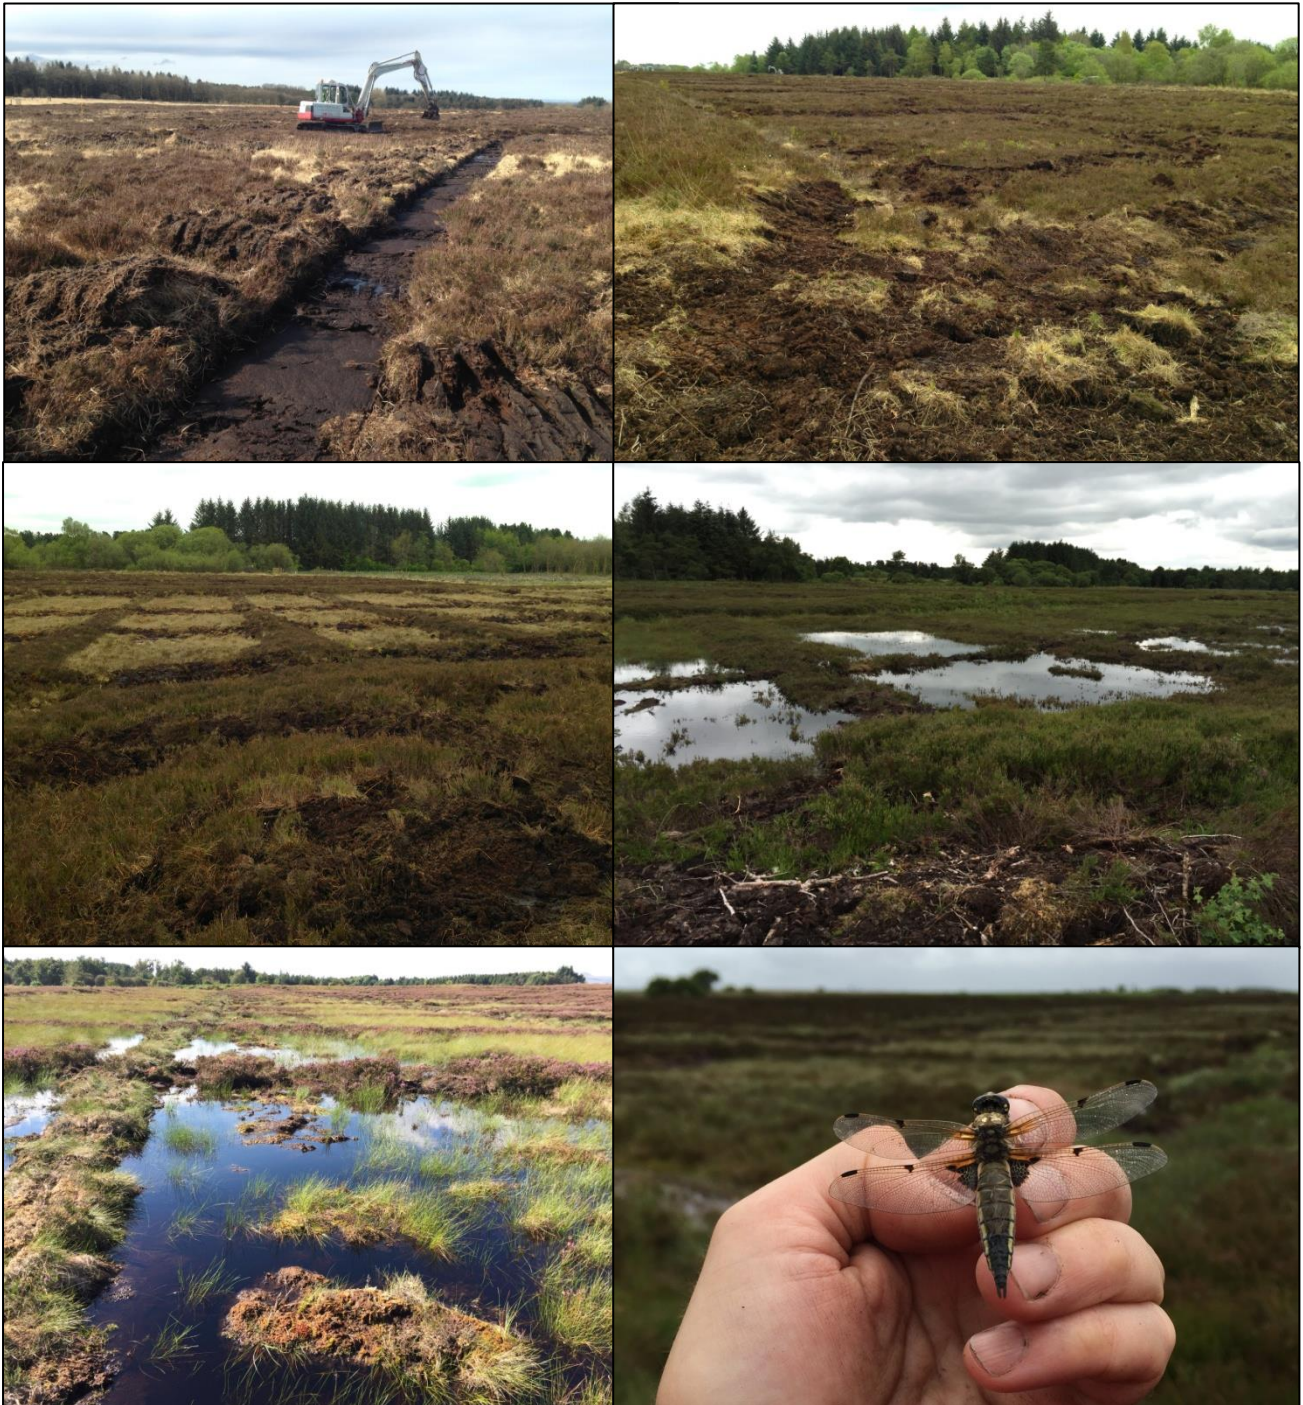
Figure 3. Installation of cell-bunding in hand-cut area of Compartment 1

Top Left: Preparing trench of compressed peat to block ditches and peat cracks prior to topping with surface bund. Top Right: After adding surface bunds. Middle Left: View facing south-west across completed cell-bunds. Middle Right: Surface water retained 2 months after cell-bund installation (June 2016). Bottom Left: Cell-bunds flooded with ~10-15cm of surface water (June 2016). Bottom Right: Four-spot chaser dragonfly one of 8 species of Odonata recorded at the newly cell-bunded area in 2016.

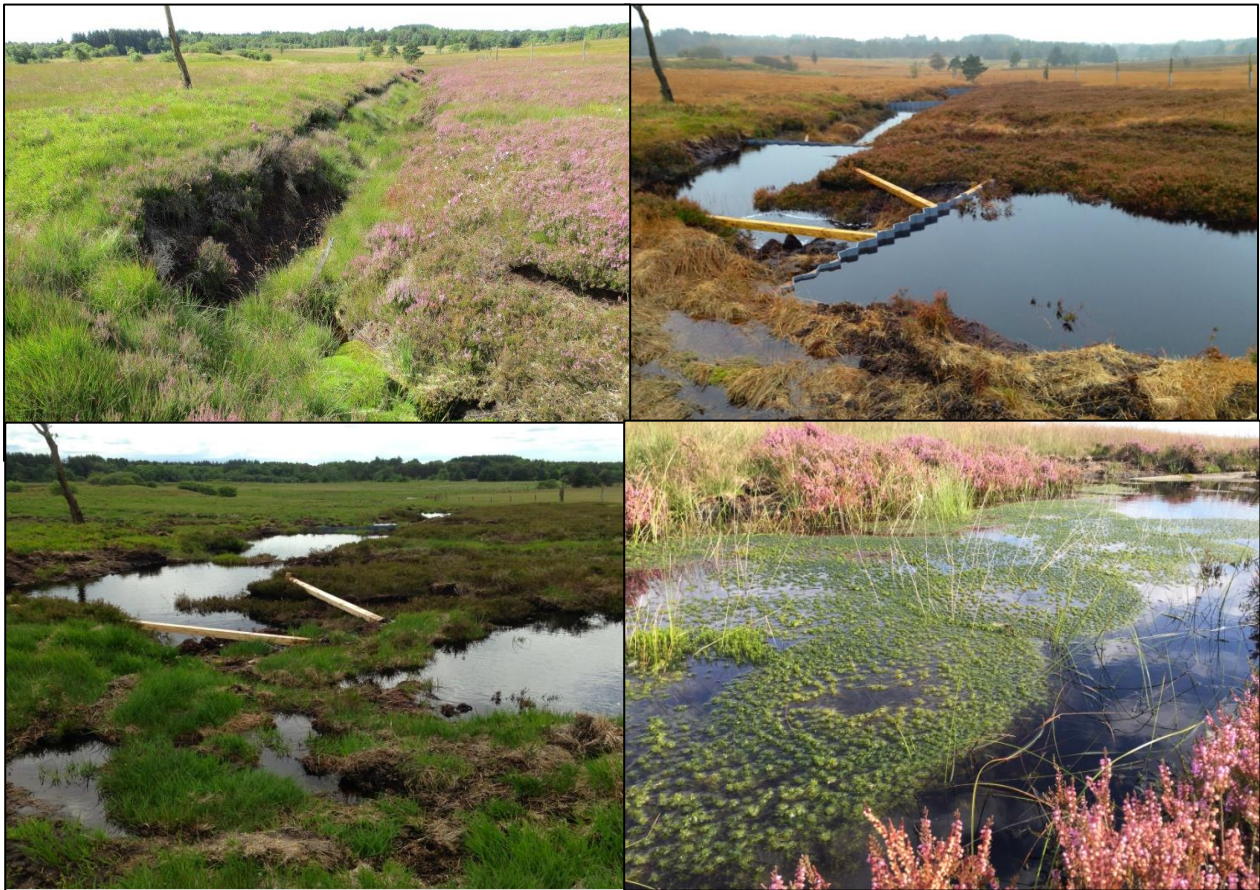
Figure 4. Large ditch in Compartment 2 at Fannyside Muir before and after installation of reinforced plastic piling dams.

Top Left: Before work began. Top Right: Ditch in late October 2015 after dam installation. Bottom Left: Ditch in June 2016 after further dams added, lower section reprofiled and existing dams backed with peat and vegetation. Bottom Right: Ditch showing *Sphagnum cuspidatum* colonisation and ovipositing dragonflies (Common hawker and Black darters)

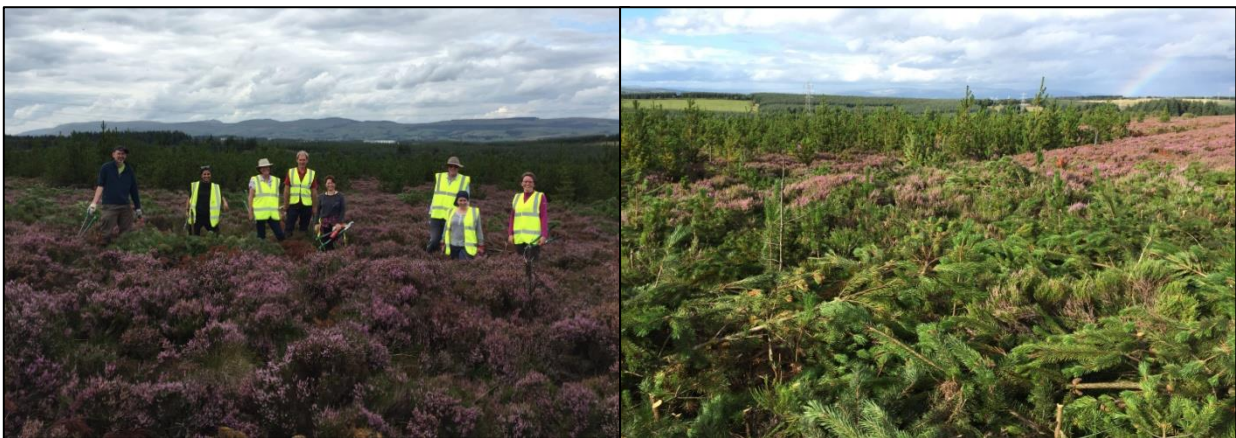
Figure 5. Clearing regenerating lodgepole pines with volunteers.

Left: Wild Reekie volunteers (August 2016) at end of workparty. Right: Some of felled conifers before they were added to blocked ditches to help slow water evaporation.

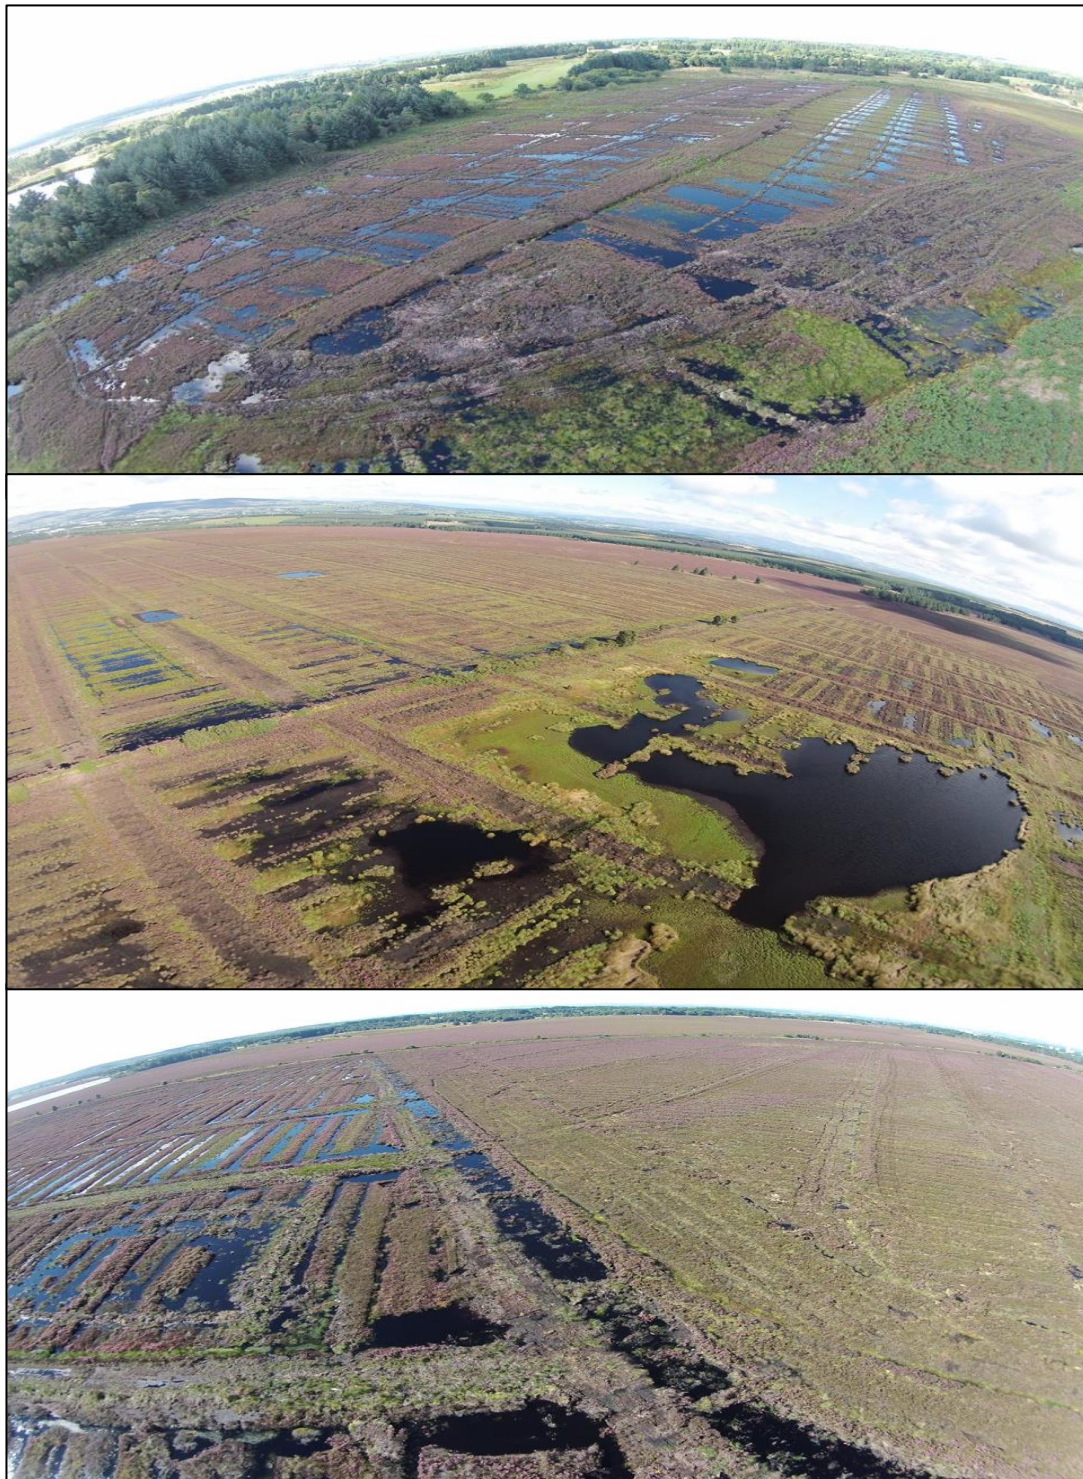
Figure 6. Aerial photographs of restoration work

Top: Cell-bunding in Compartment 1. Middle: Looking north-west over Fannyside Muir from carpark on Fannyside Road. Showing extent of roost pools in Compartment 11 and new pools created in Compartment 10. Bottom: Reprofiled, dammed ditch between re-wetted Compartment 8 (left) and new area 'C' (right) after removal of lodgepole pines and installation of peat dams on larger ditches. All photos taken September 2016 with kind assistance of RSPB Glasgow & South West Scotland staff using an aerial drone.

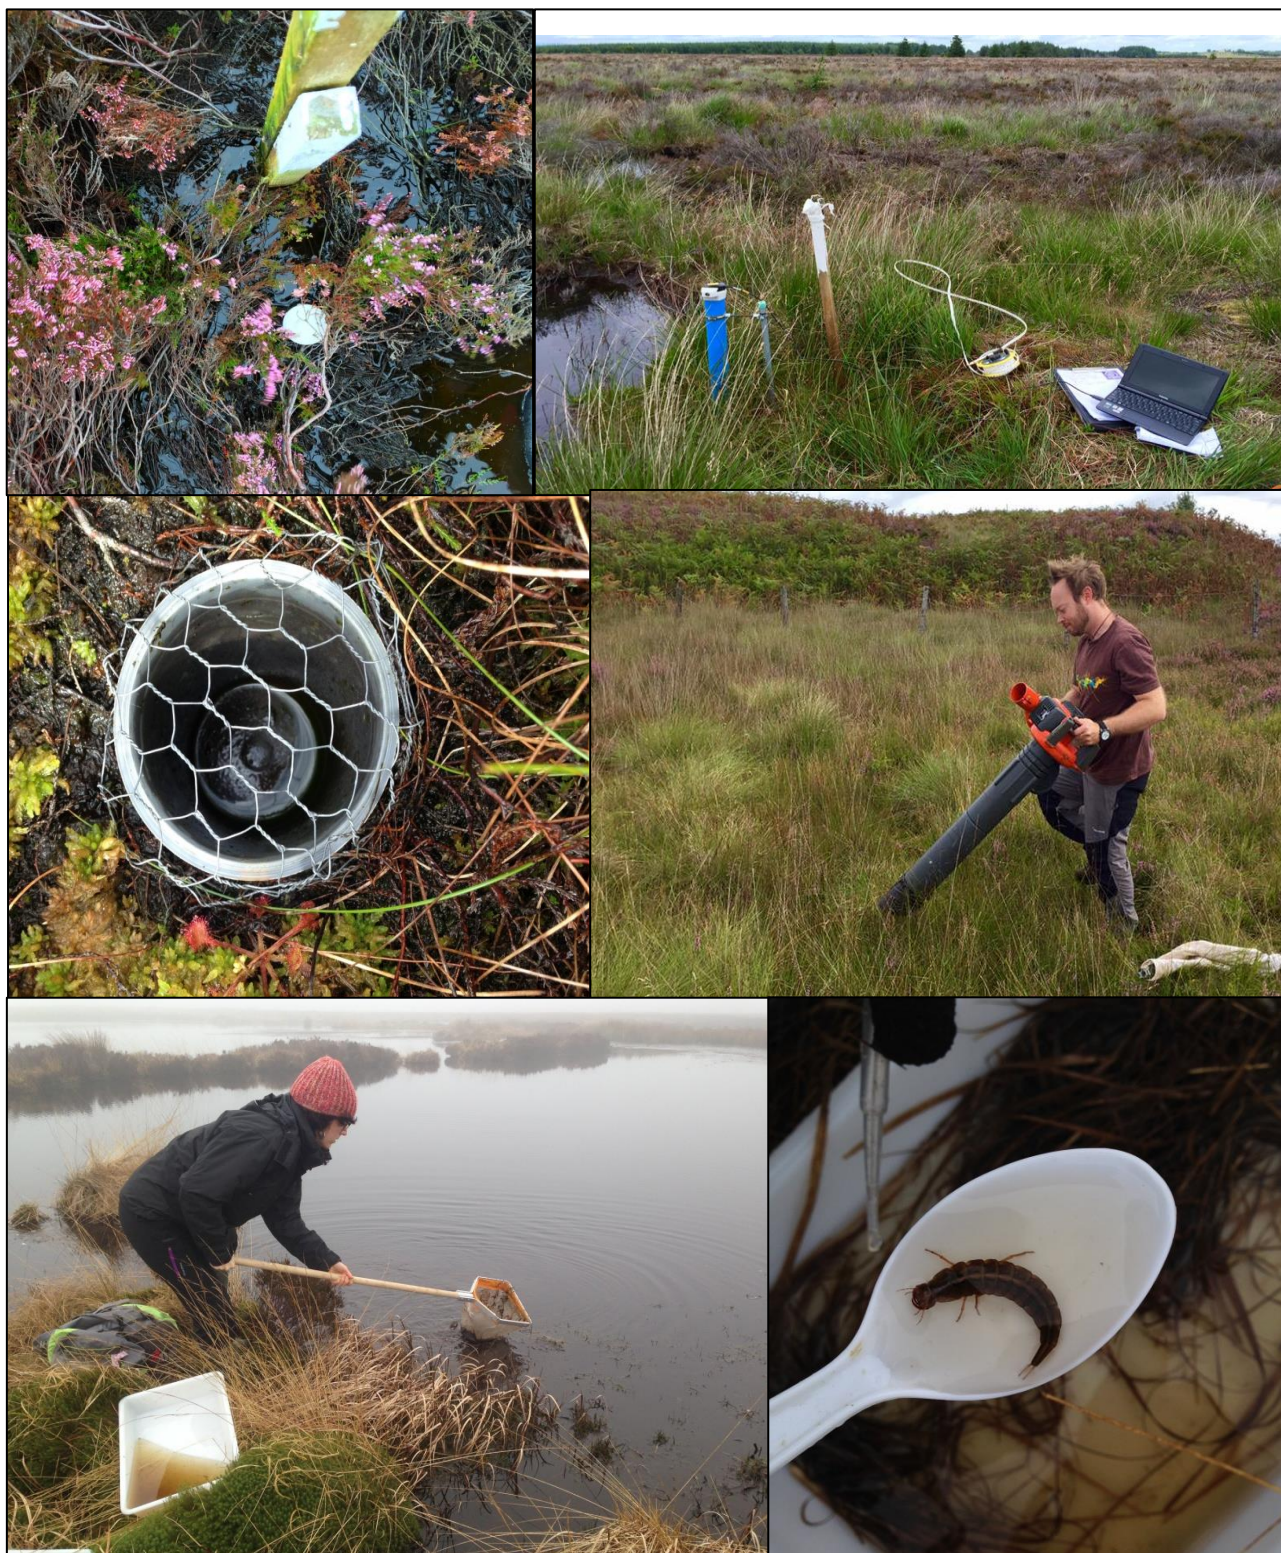
Figure 7. Monitoring at Fannyside.

Top Left: Dipwell (flooded in compartment 1). Top Right: Downloading hydrology data from logger. Centre Right: Pitfall trap. Centre Left: Bog sun-jumper spider survey using Bug-Vac (with Caledonian Conservation Ltd). Bottom Left: Aquatic invertebrate sampling in goose roost pools (Compartment 11). Bottom Right: Diving beetle larva from recently blocked ditch.
