Slamannan Bog Restoration Project

Year 2 Report

23rd November 2016

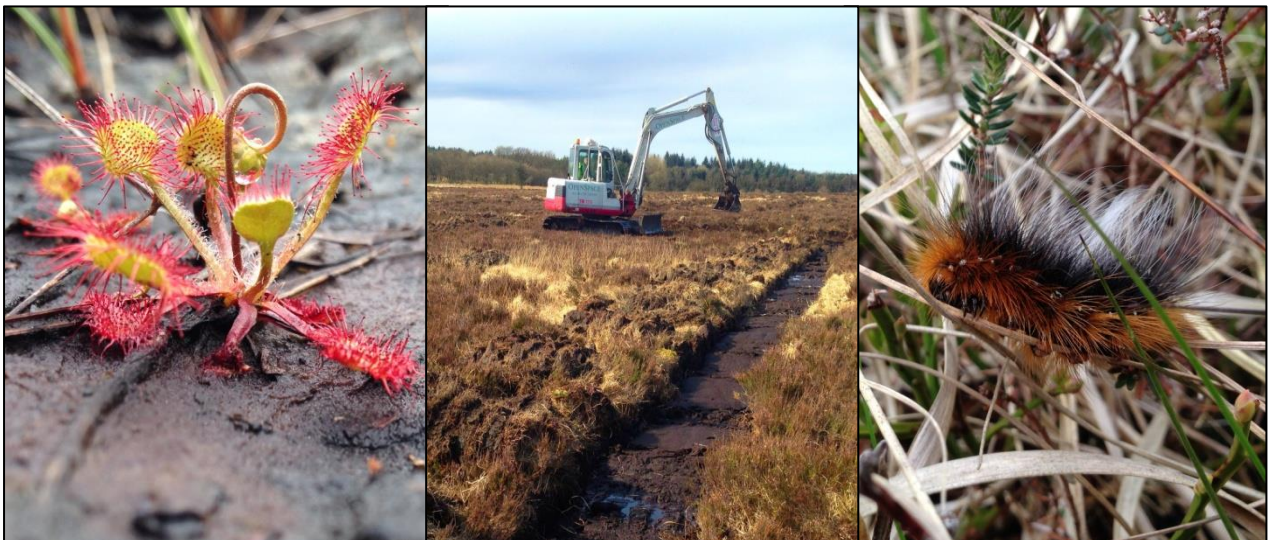
Left: Round-leaved sundew. Centre: Deep-trench cell-bunding, before top bund added. Right: Garden tiger moth caterpillar

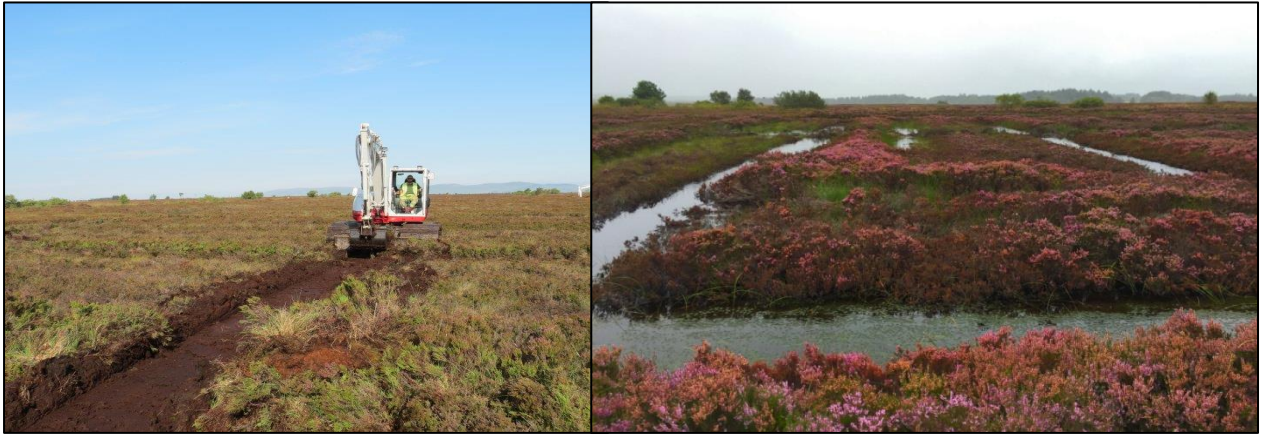
Figure 1. Installation of linear trench bund in Compartment 13a.

Top Left: Excavator installing trench bund (2 m deep) in August 2015. Top Right: Bund and peat dams working to raise water level to surface of compartment in August 2016.

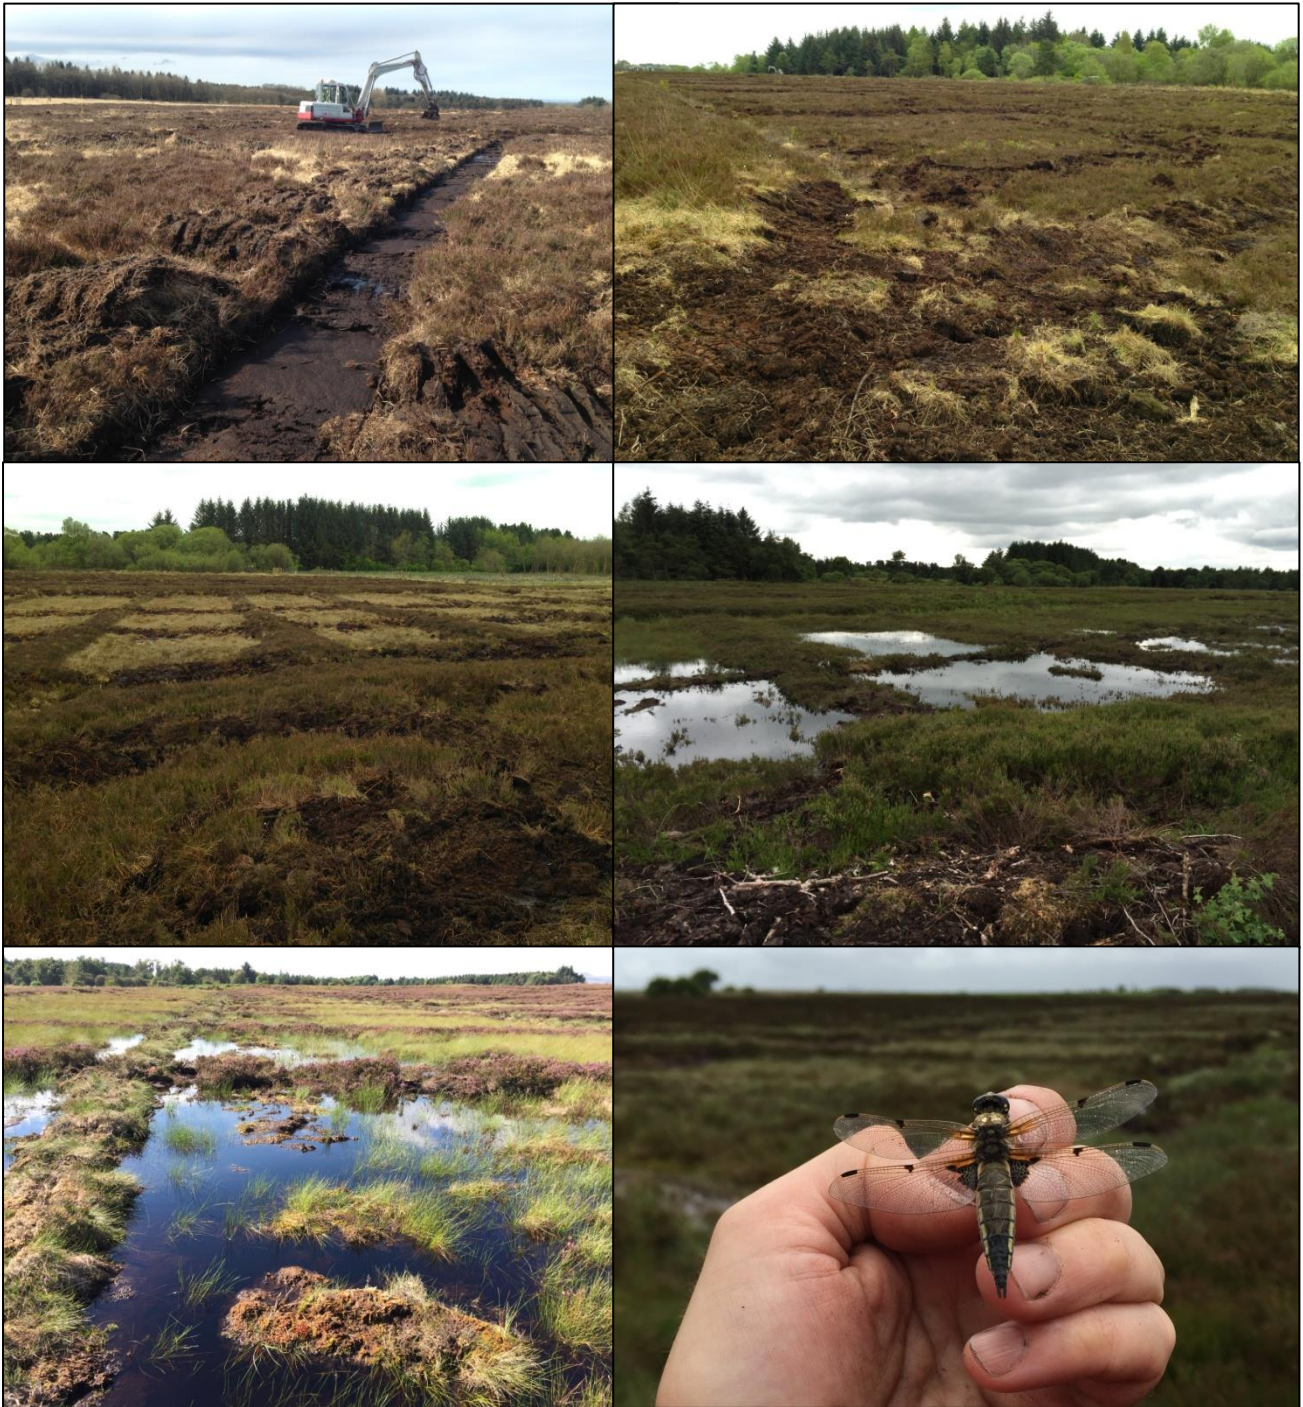
Figure 3. Installation of cell-bunding in hand-cut area of Compartment 1

Top Left: Preparing trench of compressed peat to block ditches and peat cracks prior to topping with surface bund. Top Right: After adding surface bunds. Middle Left: View facing south-west across completed cell-bunds. Middle Right: Surface water retained 2 months after cell-bund installation (June 2016). Bottom Left: Cell-bunds flooded with ~10-15cm of surface water (June 2016). Bottom Right: Four-spot chaser dragonfly one of 8 species of Odonata recorded at the newly cell-bunded area in 2016.

This activity was trialled in 2015 in a few small areas of Compartments 6 and 7, where three cell-bunds of approximately 20m x 20m were created with a 15cm high bund on top. The main aim of this technique is to use a deep trench of compressed peat to restrict sub-surface water flow, with a small top bund to slow surface water movement. On highly damaged sites ditches, forestry plough furrows, peat cracks, slumping or tree root damage can draw water away from the peat surface and this restricts peat-forming conditions. The deep trench technique restricts the water loss by creating an underground 'wall of wet putty' peat, which slows water movement. This improves hydrological connectivity and rehydrates the entire peat resource with improved water table conditions. The small bund on top helps to retain a shallow pool of surface water which helps to encourage Sphagnum recolonisation. This technique was used extensively in Compartments 1 and 2 during 2016, and in a new area of degraded bog near Palacerigg Country Park (see Figures 3 and 6). In total 26 ha of cell-bunding was installed at Fannyside Muir during year 2.

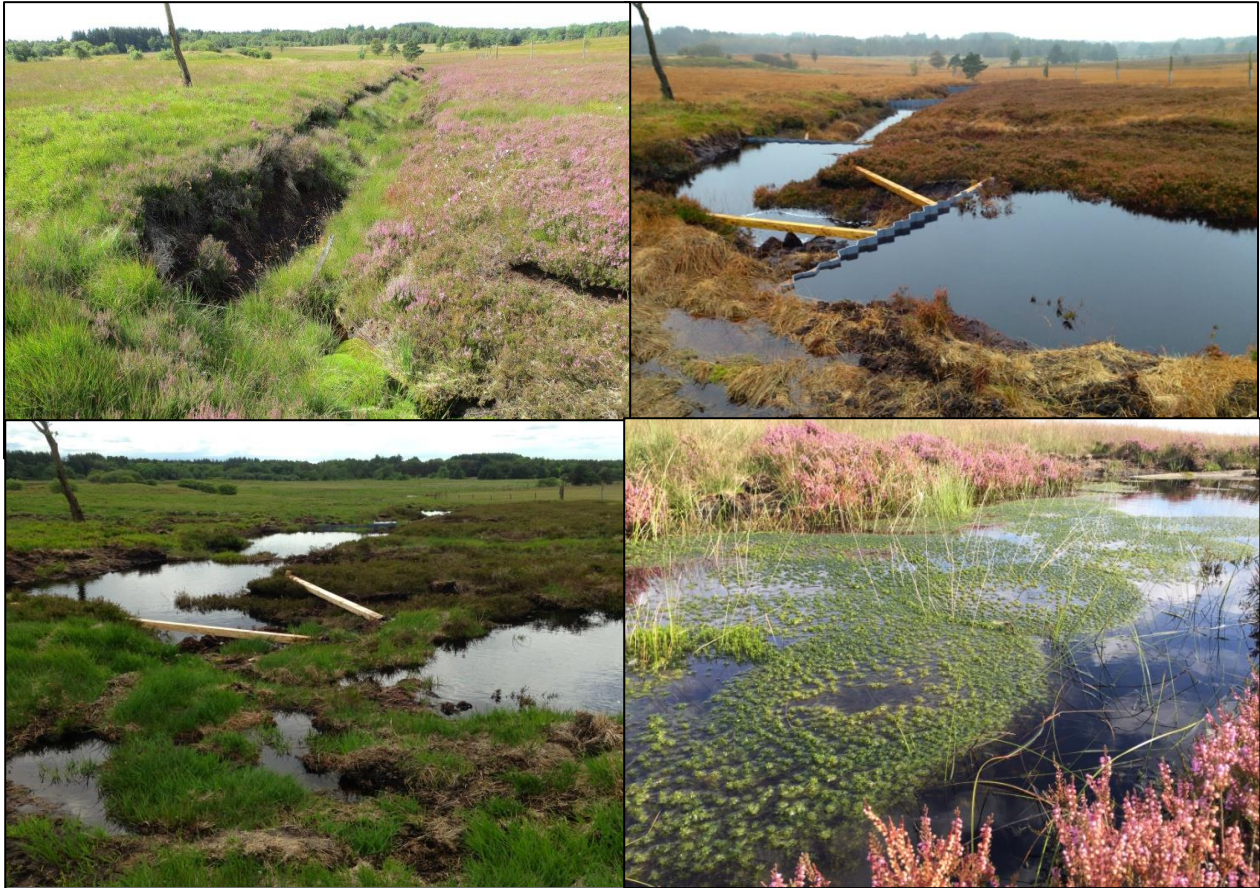
Figure 4. Large ditch in Compartment 2 at Fannyside Muir before and after installation of reinforced plastic piling dams.

Top Left: Before work began. Top Right: Ditch in late October 2015 after dam installation. Bottom Left: Ditch in June 2016 after further dams added, lower section reprofiled and existing dams backed with peat and vegetation. Bottom Right: Ditch showing *Sphagnum cuspidatum* colonisation and ovipositing dragonflies (Common hawker and Black darters)

Drainage ditches across the project area were blocked using a combination of recycled plastic sheeting and peat dams to retain water on the site. This will help increase the summer water table on the site to stimulate the recovery of bog-forming sphagnum species. The number and size of ditches varies on each of the bog compartments, thus the frequency and size of dams required also varied across the site (see Figures 2, 4 and 6).

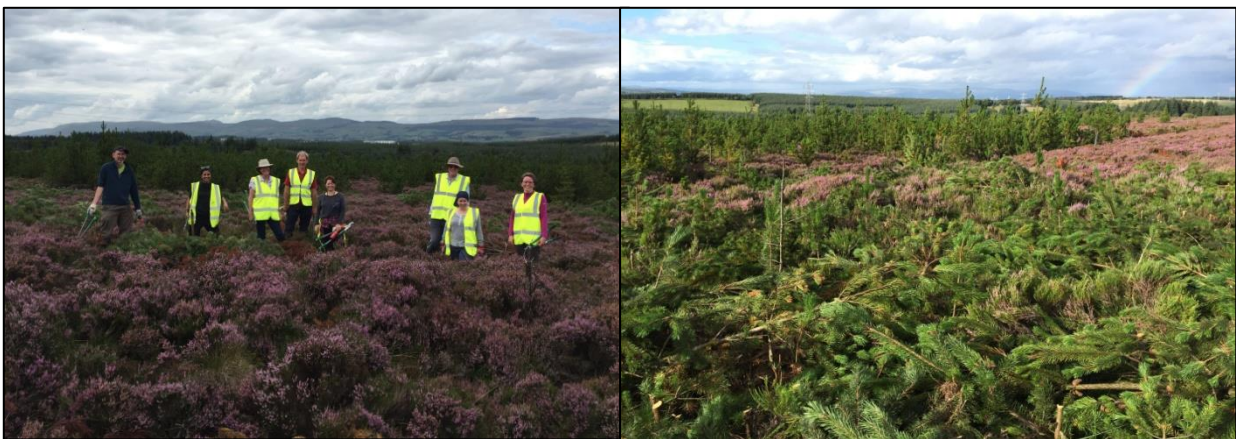
Figure 5. Clearing regenerating lodgepole pines with volunteers.

Left: Wild Reekie volunteers (August 2016) at end of workparty. Right: Some of felled conifers before they were added to blocked ditches to help slow water evaporation.

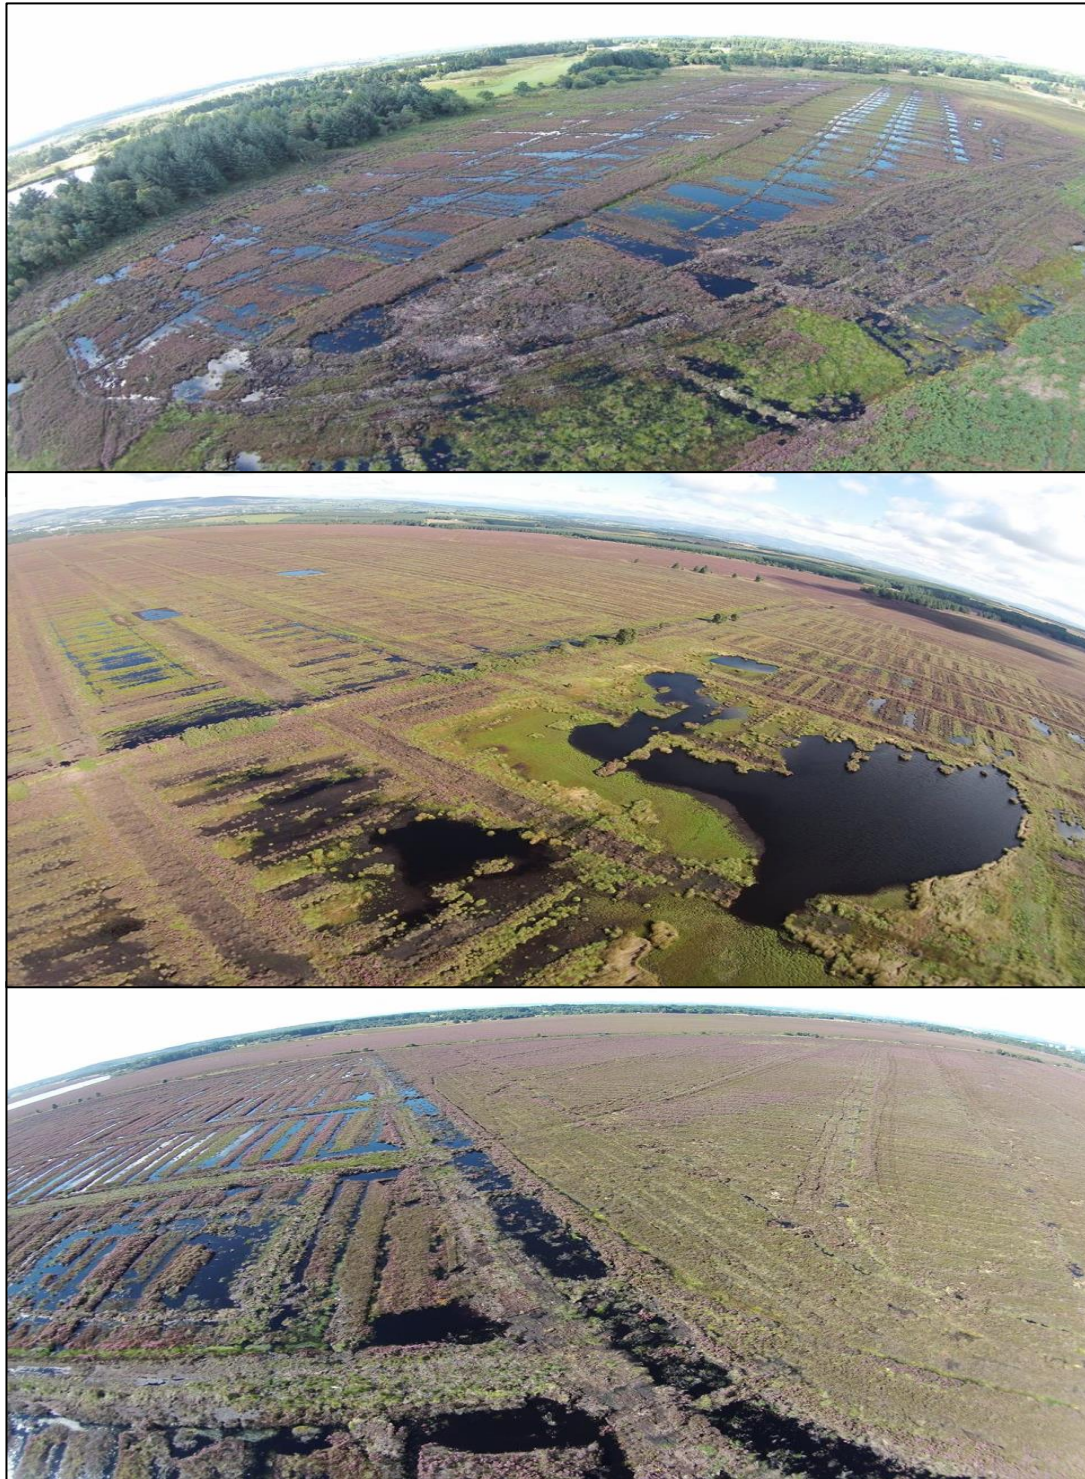
Figure 6. Aerial photographs of restoration work

Top: Cell-bunding in Compartment 1. Middle: Looking north-west over Fannyside Muir from carpark on Fannyside Road. Showing extent of roost pools in Compartment 11 and new pools created in Compartment 10. Bottom: Reprofiled, dammed ditch between re-wetted Compartment 8 (left) and new area 'C' (right) after removal of lodgepole pines and installation of peat dams on larger ditches. All photos taken September 2016 with kind assistance of RSPB Glasgow & South West Scotland staff using an aerial drone.

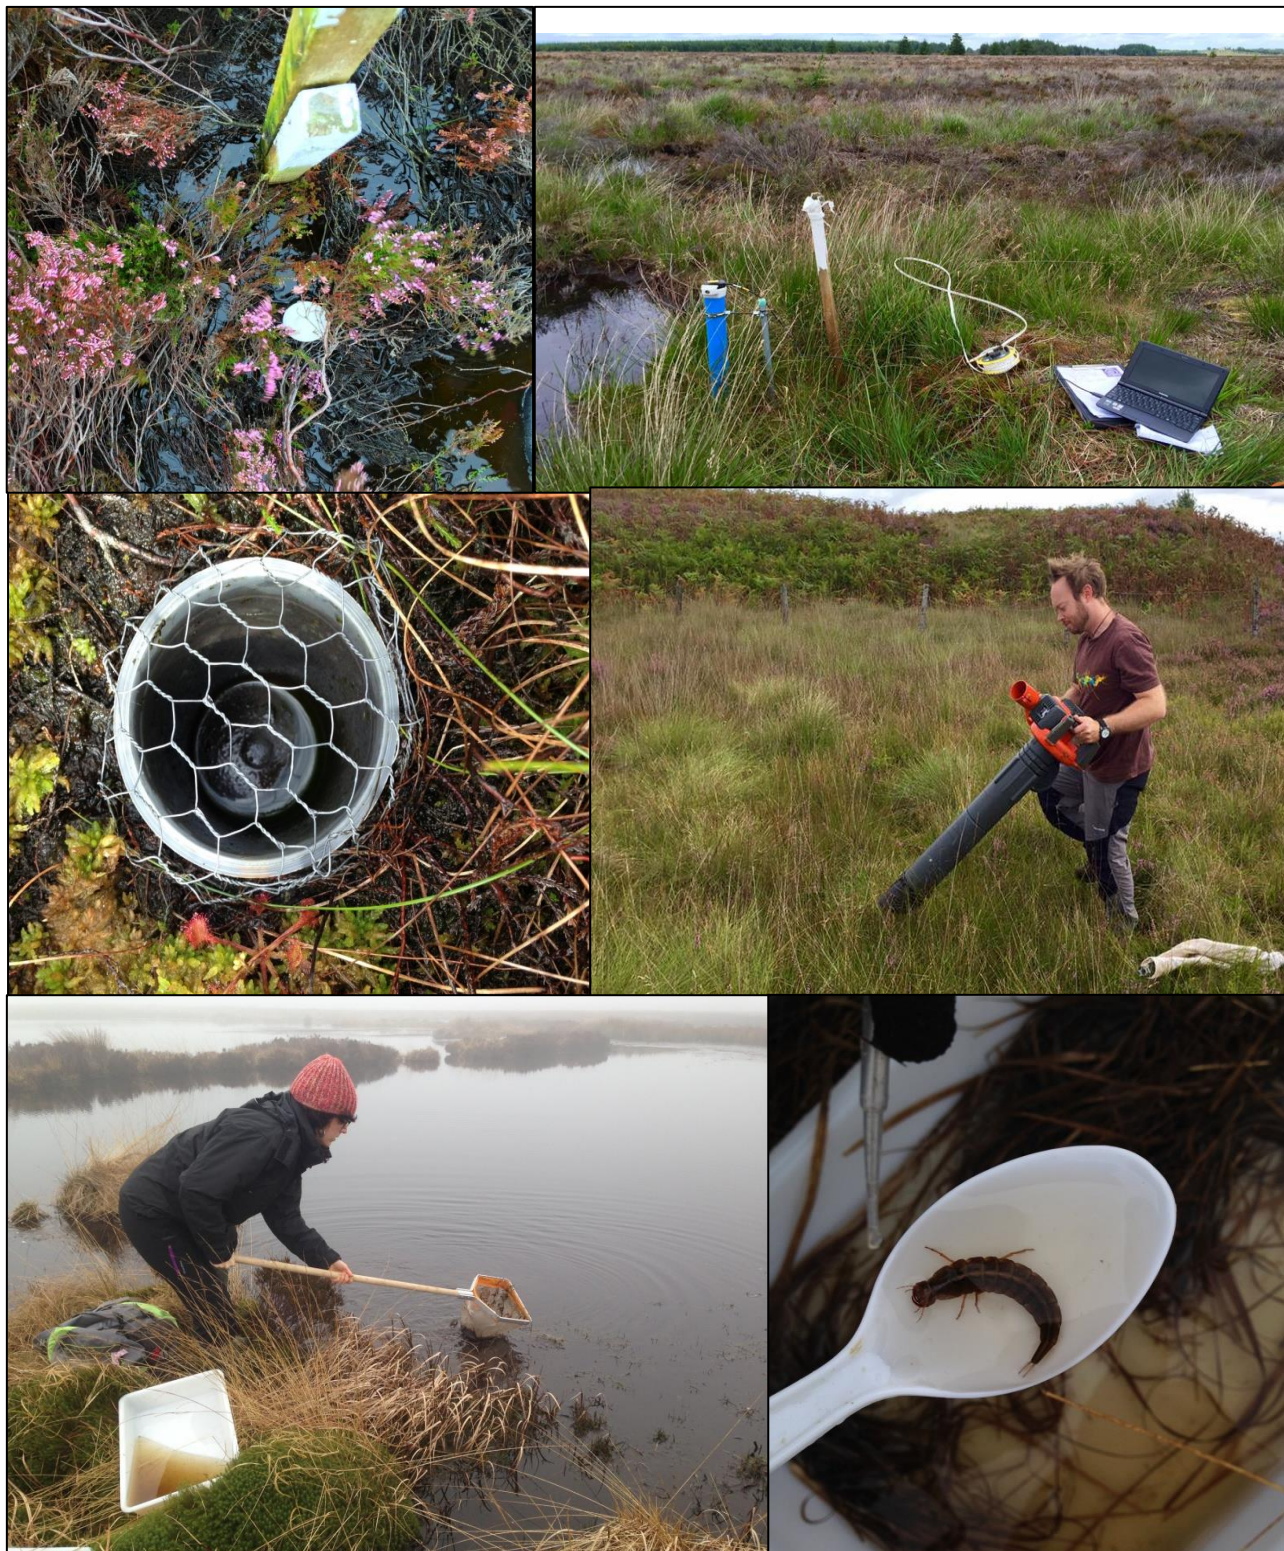
Figure 7. Monitoring at Fannyside.

Top Left: Dipwell (flooded in compartment 1). Top Right: Downloading hydrology data from logger. Centre Right: Pitfall trap. Centre Left: Bog sun-jumper spider survey using Bug-Vac (with Caledonian Conservation Ltd). Bottom Left: Aquatic invertebrate sampling in goose roost pools (Compartment 11). Bottom Right: Diving beetle larva from recently blocked ditch.

Invertebrates make up the majority of the UK's biodiversity. Analysis of the rich diversity of invertebrate species found within a site can provide useful information regarding the types and quality of the habitat present. Generalist species can be found in many different habitats and in some cases may be negative-indicators of habitat quality. On the other hand, bog specialists may be restricted to high-quality bog habitat containing the specific resources required to complete that species' lifecycle. Aquatic invertebrate surveys were carried out, sampling various bog pools and blocked ditches from March to May 2016. (Figure 7).
