Slamannan Bog Restoration Project

Year 3 Report

3rd November 2017 Dr Scott Shanks - Conservation Officer

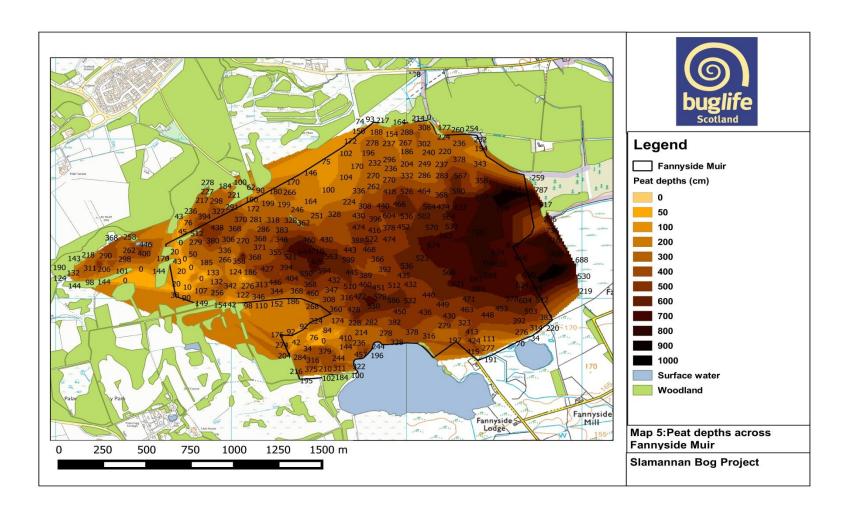
Map 5 Map showing interpolated Peat depths acros Fannyside Muir based on data obtained using peat probes to survey the depth across the site.

- An additional 430 peat depth readings were measured across the site and surrounding peat deposits. The deepest reading within the project site was 915cm, while a reading of 930cm was recorded just outside the project area.

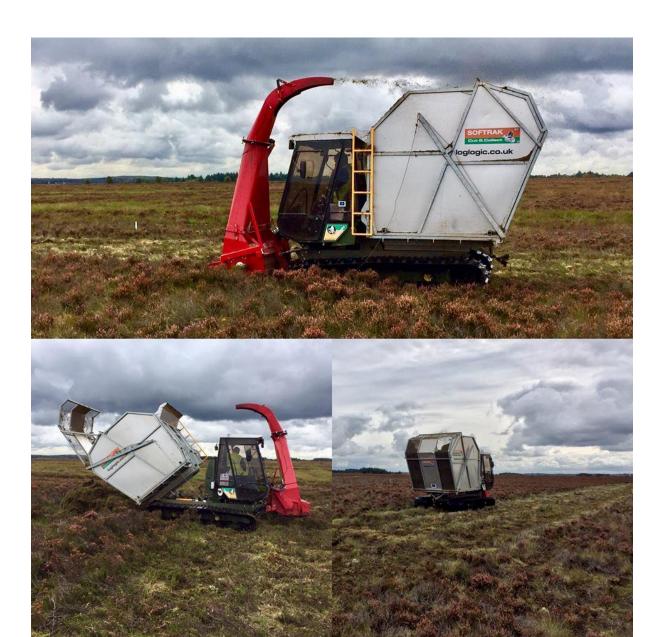
Figure 1. Heather cutting in Compartment 7.

<u>Top</u>: Softrak Loglogic 'Cut and Collect' system harvesting heather to reduce evapotranspiration. Heather brash added to surrounding ditches to help with ditch occlusion. September 2017. <u>Bottom Left:</u> Dumping heather brash into small ditch to help with occlusion. <u>Bottom Right</u>: Softrak Loglogic 'Cut and Collect' system harvesting heather. Area of bog in foreground has been cut, and brash visible in the collection cage

Heather cutting was carried out in September 2017 to help reduce evapotranspiration from areas of tall woody heather (Figure 1). Cutting was undertaken by trained SNH/ EcoCo LIFE staff using a Softrak Cut & Collect system. Due to the time of year, the area that could be cut was limited prior to the return of Taiga Bean geese in late. Approximately 1.2 ha of heather in Compartment 7 was cut, with the heather cuttings added to surrounding ditches to help with ditch occlusion.

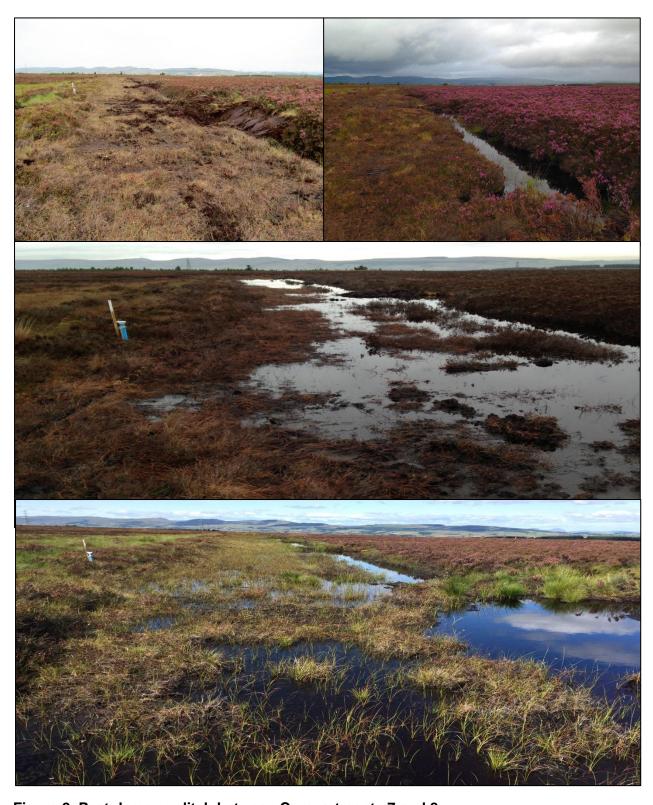
Figure 2. Peat dams on ditch between Compartments 7 and 8.

Top Left: Just after dam installation. Top Right: Late September2015 - blocked ditches filling with water. Middle: March 2016 - ground water raised to surface of the peat. Bottom: September 2017— Cottongrass and Sphagnum colonisation of blocked ditch and peat.

Drainage ditches across the project area were blocked using a combination of recycled plastic sheeting and peat dams to retain water on the site. This will help increase the summer water table on the site to stimulate the recovery of bog-forming *Sphagnum* species. The number and size of ditches varies on each of the bog compartments, thus the frequency and size of dams required also varied across the site (see Figures 2, 3 and 4).

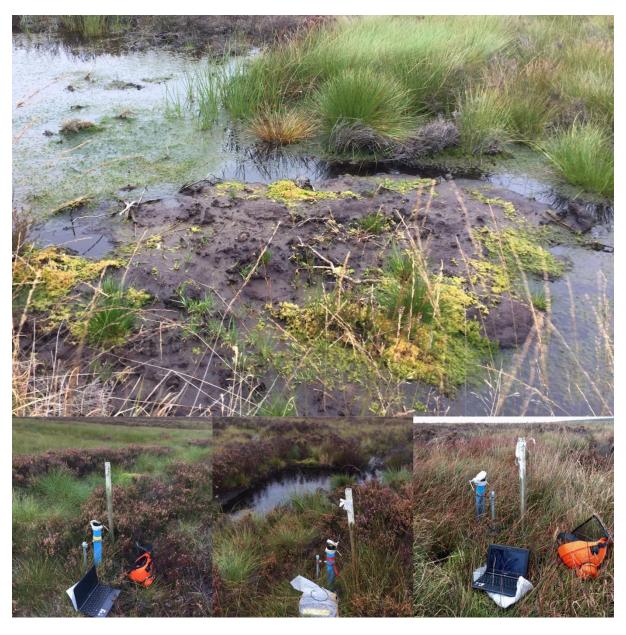
Figure 3. Successful ditch blocking at Fannyside Muir to raise water table and promote Sphagnum colonisation.

<u>Top</u>: A ditch blocked with peat dams in Compartment 10 (in 2015) showing good Sphagnum colonisation both in ditch and on surface of peat dam. Cottongrass colonisation also evident. <u>Bottom Left, Middle and Right</u>: Downloading data from the 3 water depth data loggers at Fannyside Muir in September 2017

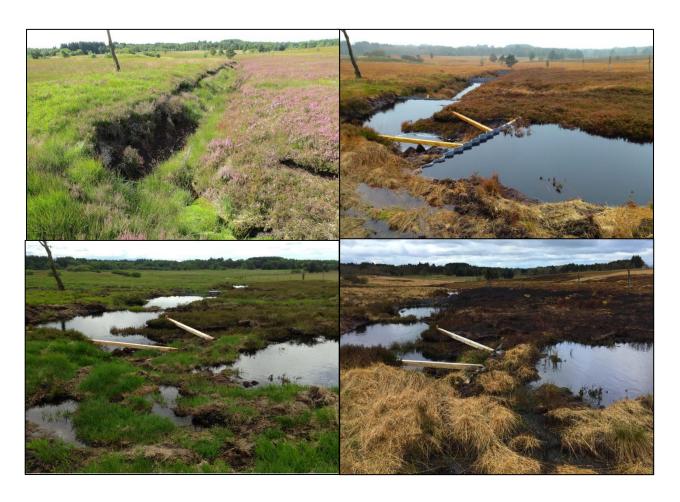
Figure 4. Large blocked ditch in Compartment 2 at Fannyside Muir helped to constrain spread of fire in April 2017

<u>Top Left</u>: Before work began. <u>Top Right</u>: Ditch in late October 2015 after dam installation. <u>Bottom Left</u>: Ditch in June 2016 after further dams added, lower section reprofiled and existing dams backed with peat and vegetation. <u>Bottom Right</u>: Spread of fire in April 2017 constrained by water-filled ditch (dark area on opposite side of ditch is burnt vegetation).

- A grass fire in April 2017 damaged approx.1 ha of Compartment 2 (next to Palacerigg Country Park) however, surrounding blocked ditches and re-wetted areas limited the spread of the fire.
