## SUMMARY

The Slamannan Bog Restoration Project began in September 2014 with the aim of restoring at least 150 hectares (ha) of degraded raised bog habitat in the Slamannan Plateau. The project is focused on an area of peatland called Fannyside Muir, 3km from Cumbernauld.

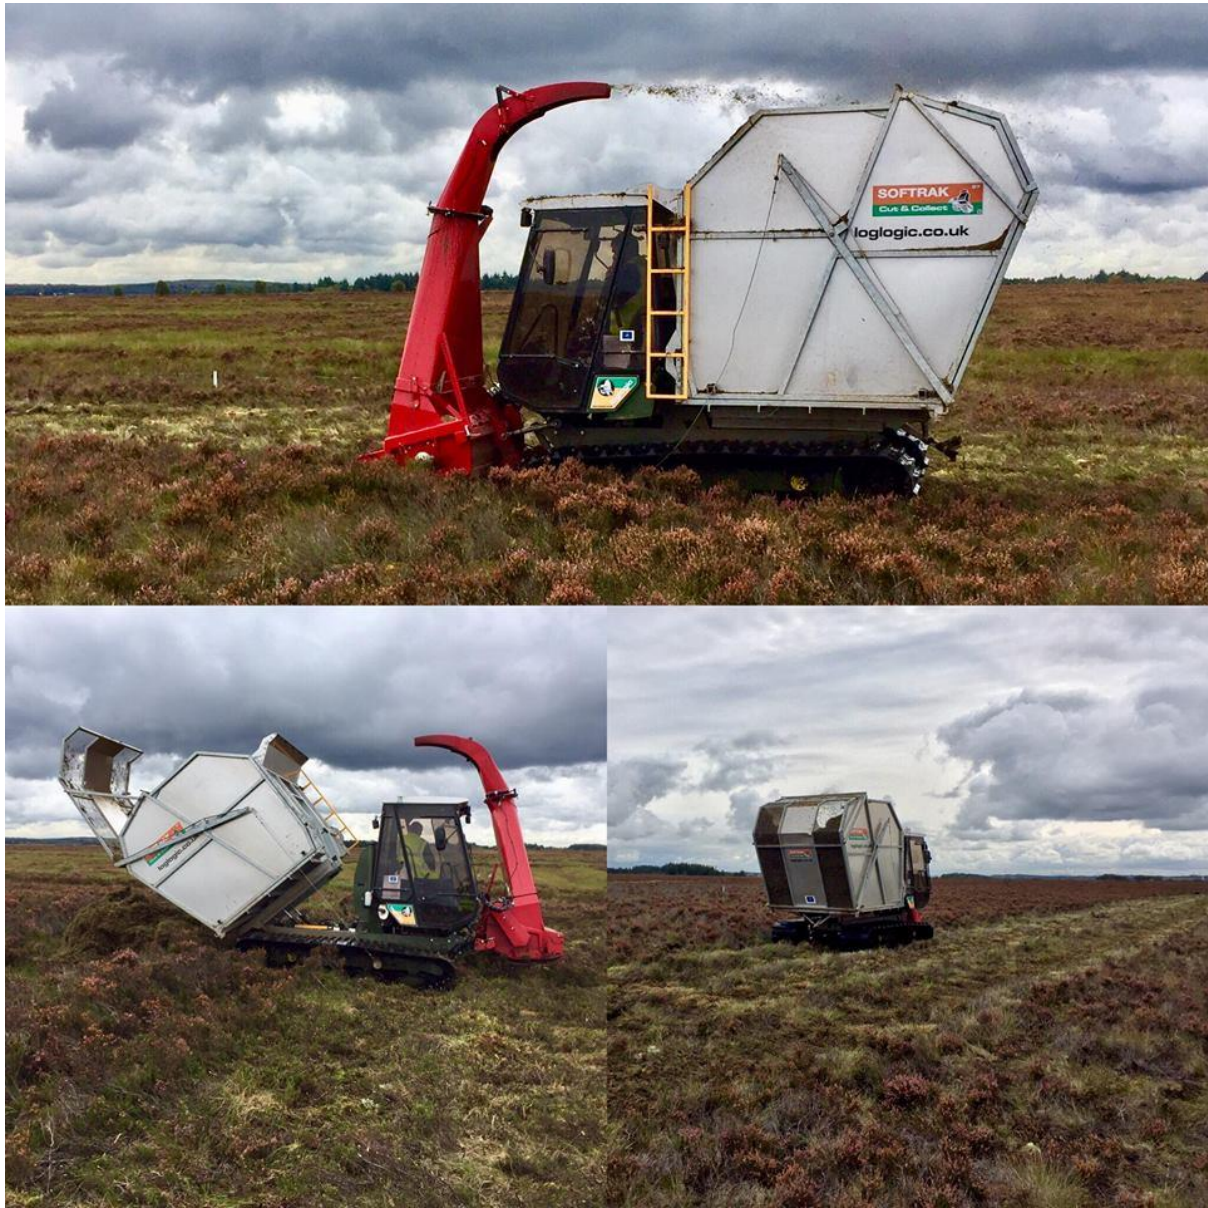
**Figure 1. Heather cutting in Compartment 7.**

Top: Softrak Loglogic 'Cut and Collect' system harvesting heather to reduce evapotranspiration. Heather brash added to surrounding ditches to help with ditch occlusion. September 2017. Bottom Left: Dumping heather brash into small ditch to help with occlusion. Bottom Right: Softrak Loglogic 'Cut and Collect' system harvesting heather. Area of bog in foreground has been cut, and brash visible in the collection cage

- Heather cutting was carried out in September 2017 to help reduce evapotranspiration from areas of tall woody heather. Cutting was undertaken by trained SNH/ EcoCo LIFE staff using a Softrak Cut & Collect system. Due to the time of year, the area that could be cut was limited prior to the return of Taiga Bean geese in late September. Approximately 1.2 ha of heather in Compartment 7 was cut, with the heather cuttings added to surrounding ditches to help with ditch occlusion.

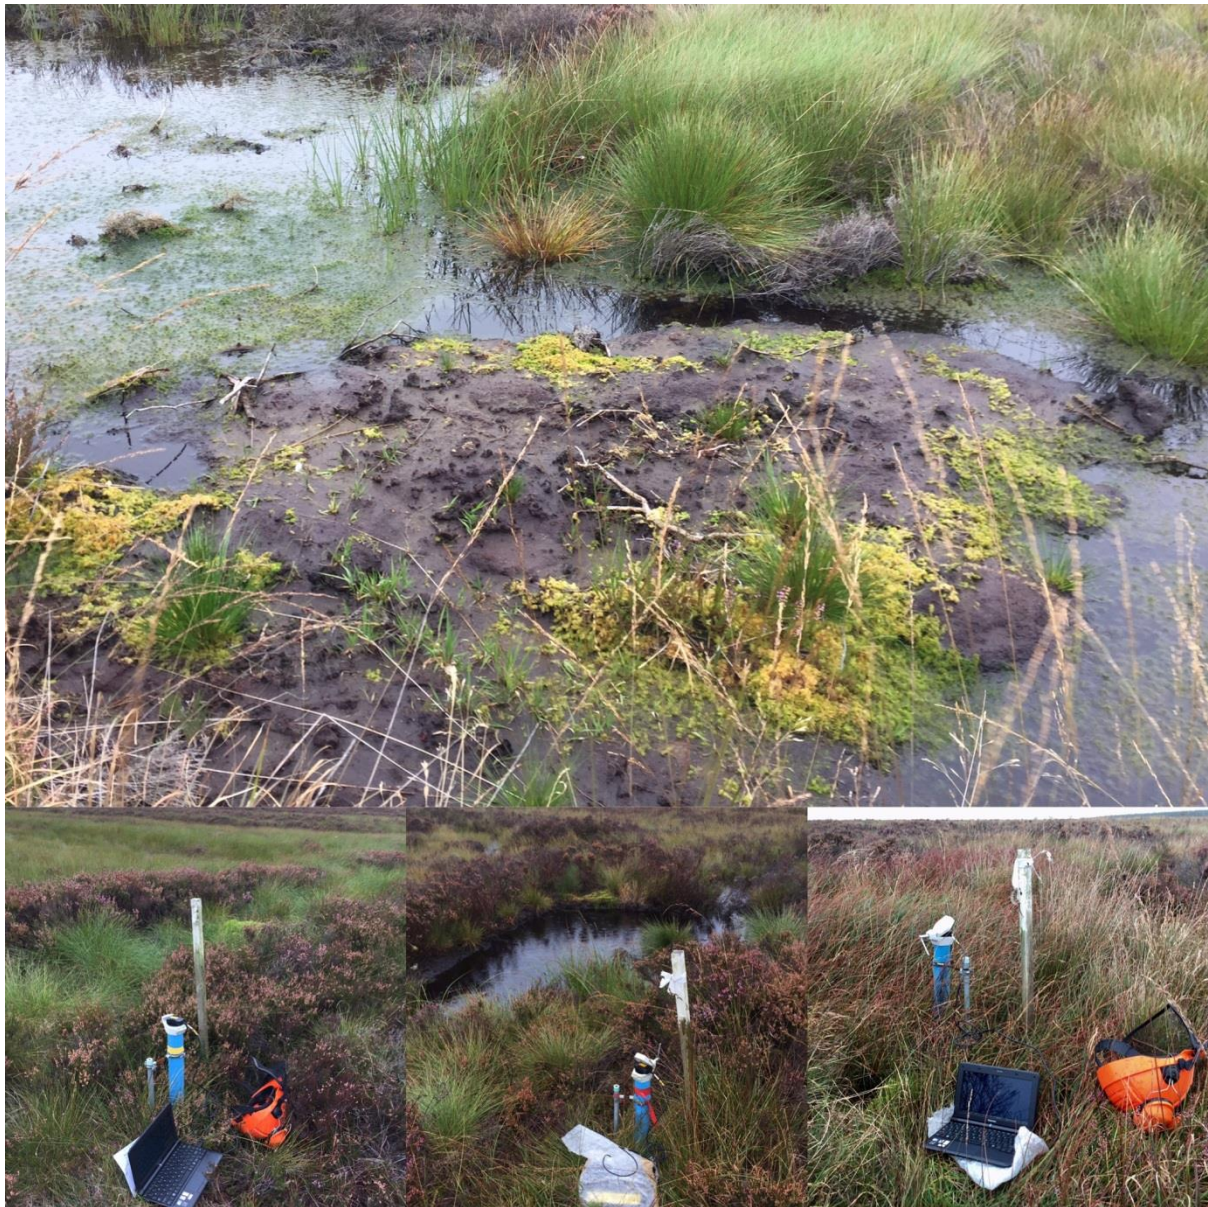
**Figure 3. Successful ditch blocking at Fannyside Muir to raise water table and promote *Sphagnum* colonisation.**

Top: A ditch blocked with peat dams in Compartment 10 (in 2015) showing good *Sphagnum* colonisation both in ditch and on surface of peat dam. Cottongrass colonisation also evident.  
Bottom Left, Middle and Right: Downloading data from the 3 water depth data loggers at Fannyside Muir in September 2017

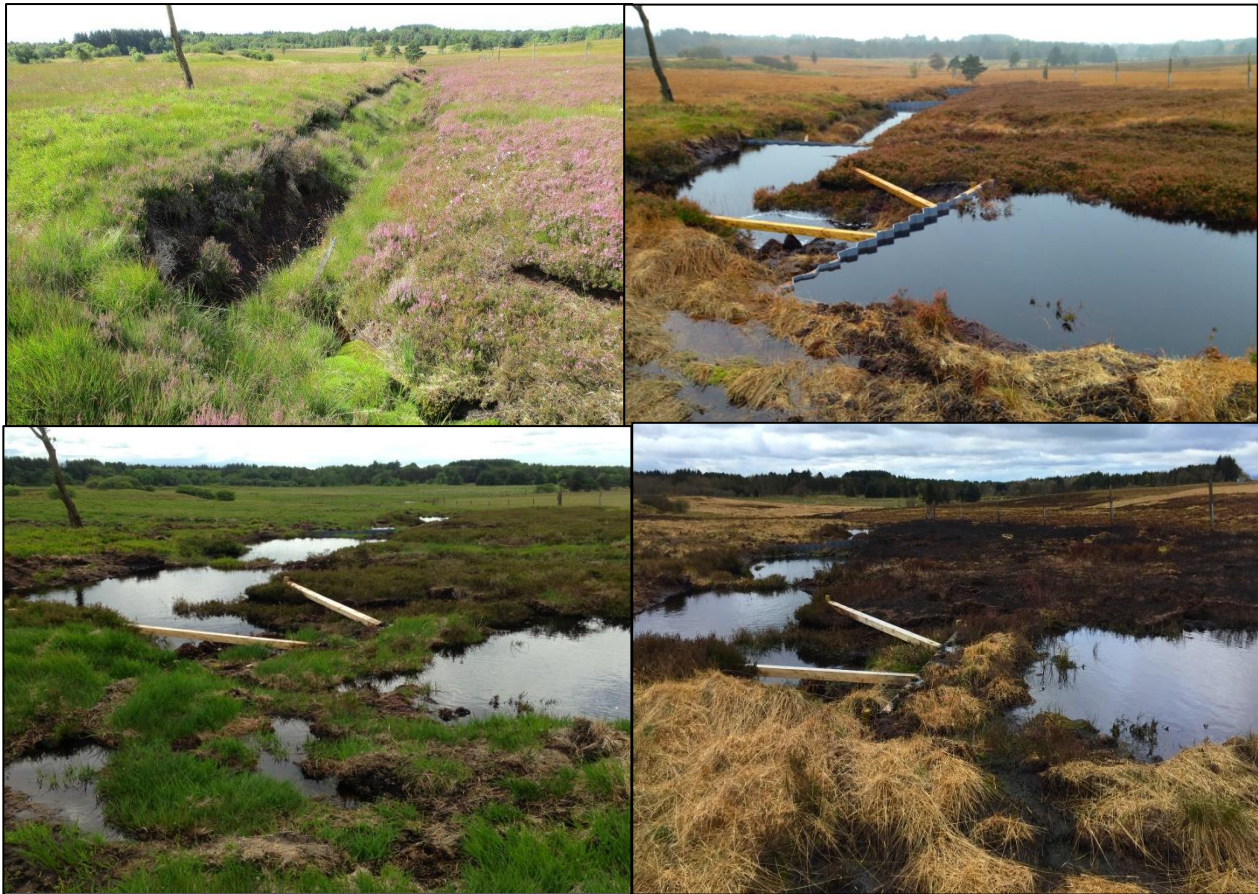
**Figure 4. Large blocked ditch in Compartment 2 at Fannyside Muir helped to constrain spread of fire in April 2017**

Top Left: Before work began. Top Right: Ditch in late October 2015 after dam installation. Bottom Left: Ditch in June 2016 after further dams added, lower section reprofiled and existing dams backed with peat and vegetation. Bottom Right: Spread of fire in April 2017 constrained by water-filled ditch (dark area on opposite side of ditch is burnt vegetation).

- A grass fire in April 2017 damaged approx.1 ha of Compartment 2 (next to Palacerigg Country Park) however, surrounding blocked ditches and re-wetted areas limited the spread of the fire.
